**Updated Integrated Environmental  
Recovery Plan  
PRAI**

**December 2016**

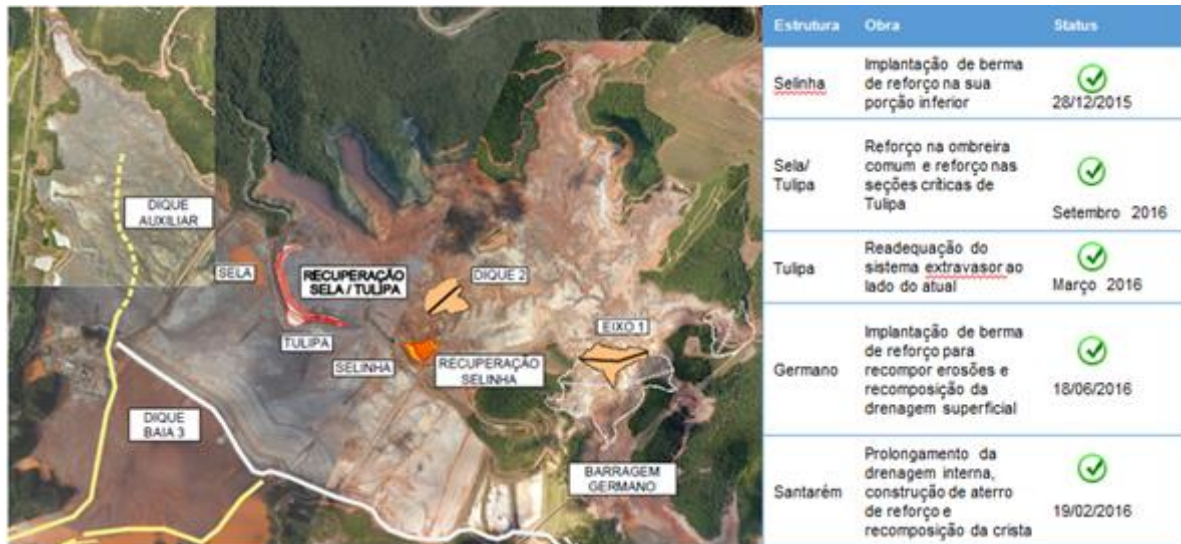
Figure 8 : Emergency works of containment and stabilization executed during the rainy period 2015/2016

All of the structures already have global (overall) safety factors above 1.5; as indicated in **Table 2**.

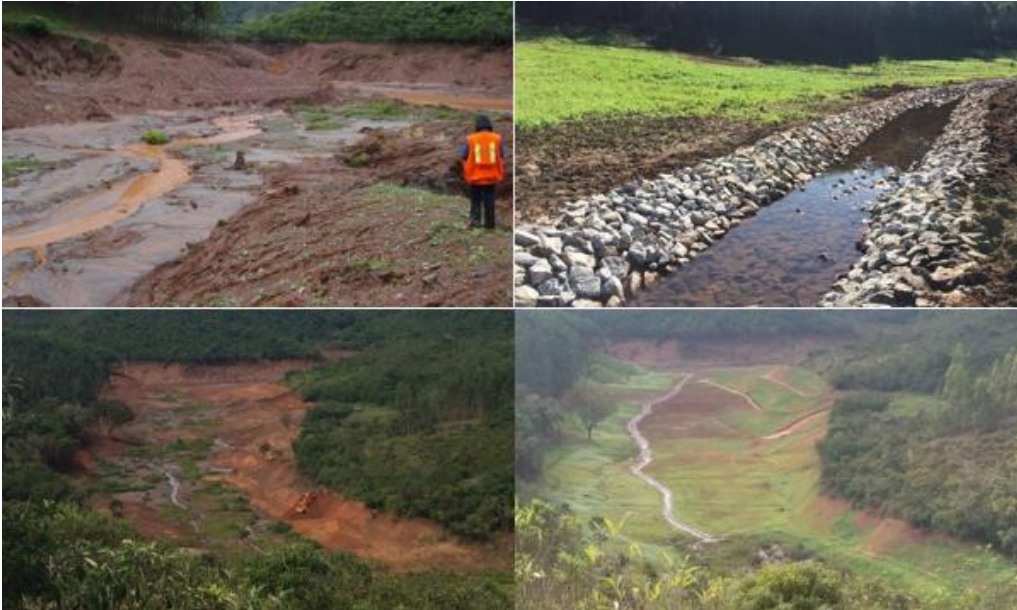
### **Tributary 5 of the Gualaxo do Norte River (TG05)**

*Figure 21: Environmental recovery of the tributary TG05.*

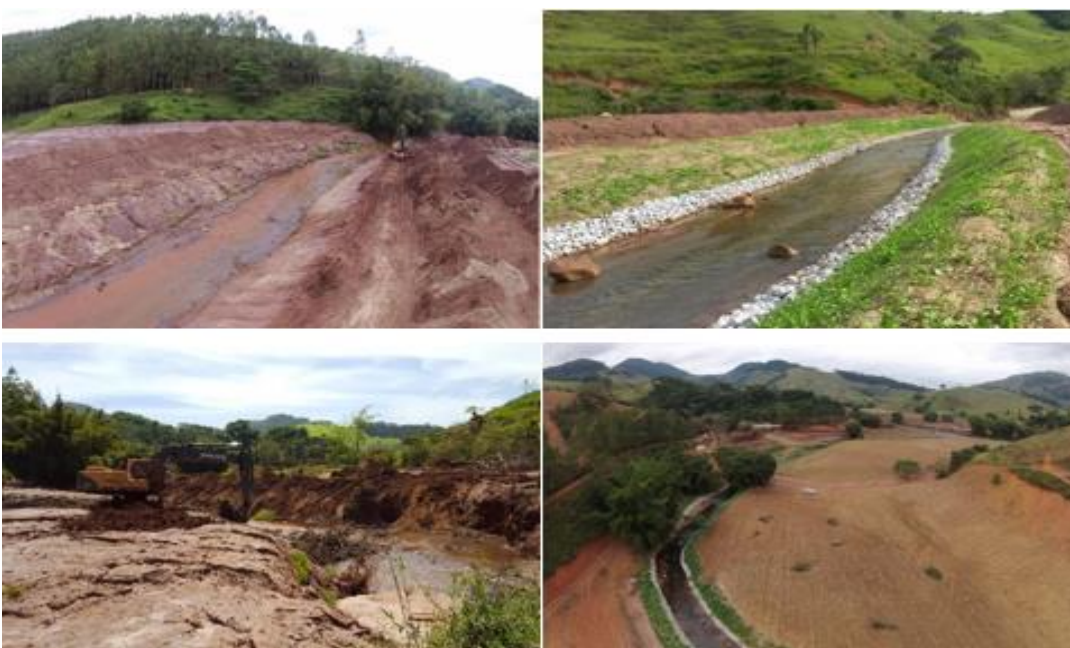
### **Tributary 49 of the Gualaxo do Norte River (TG49)**

*Figure 22: Environmental recovery of the tributary TG49.*

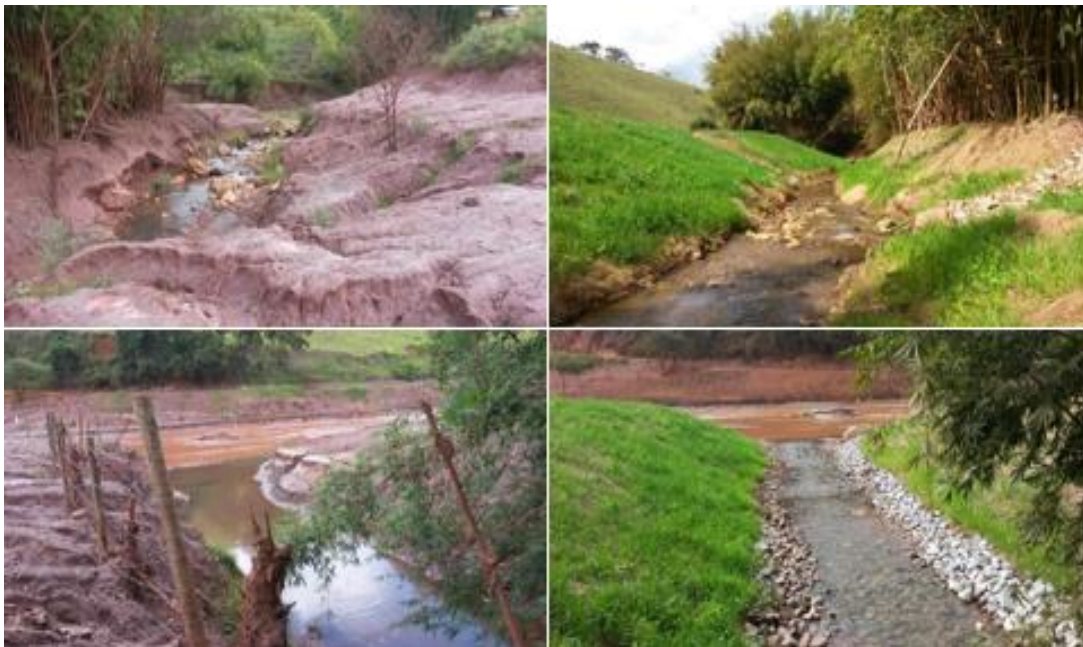
### **Tributary 51 of the Gualaxo do Norte River (TG51)**

Figure 23: Environmental recovery of tributary TG51.

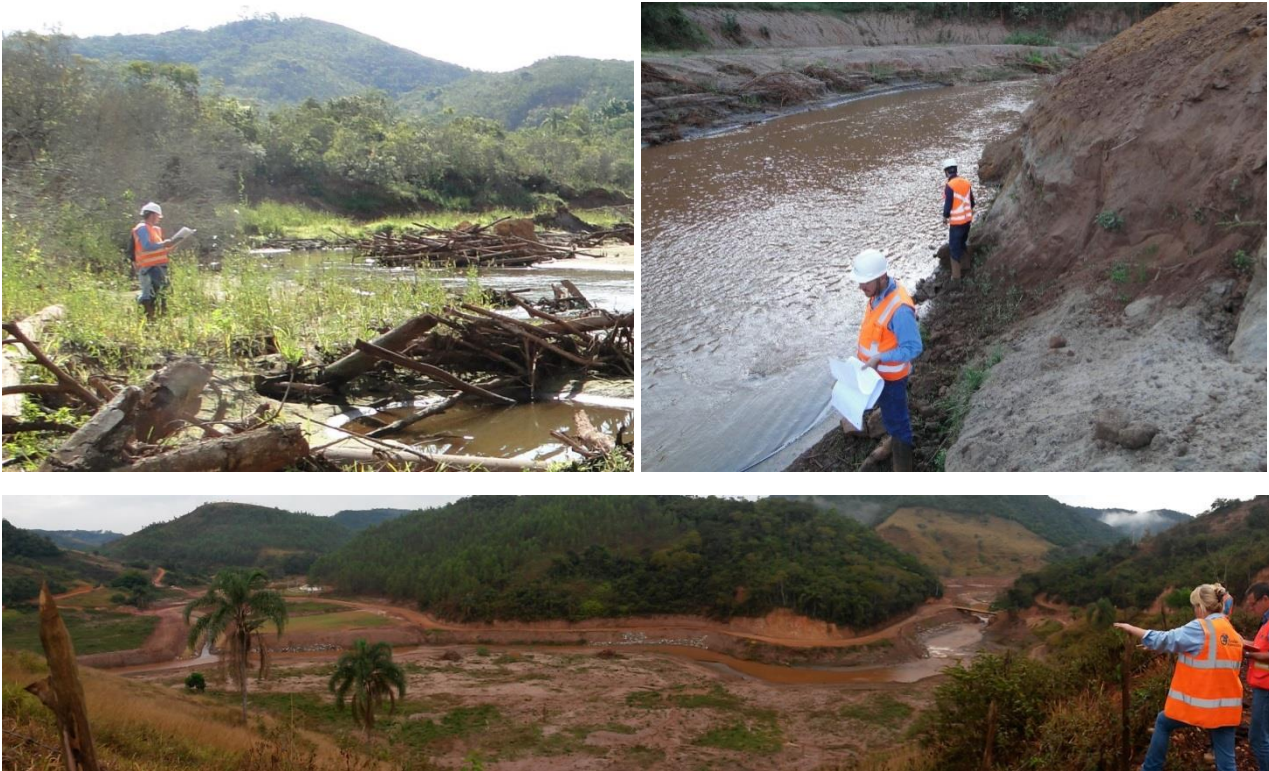
commonly for the majority of the areas visited. See below some photos of the field work done by the Golder team.

Figure 26 Field Survey executed by the Golder team.

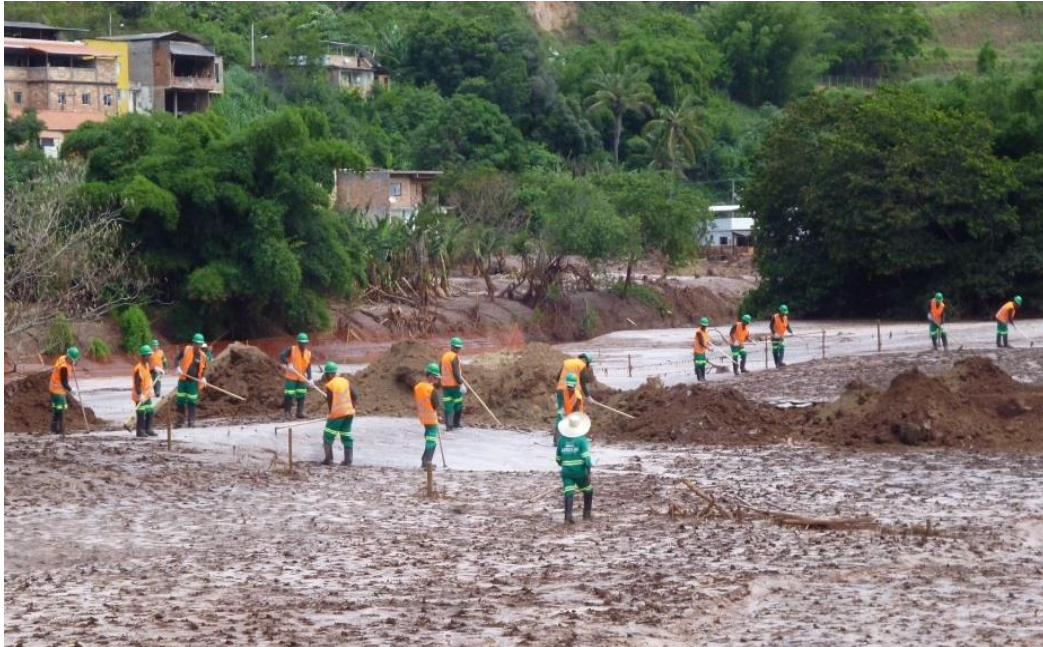
*Figure 40: Manual micro planting holes of the soil using small hoes near Barra Longa.*

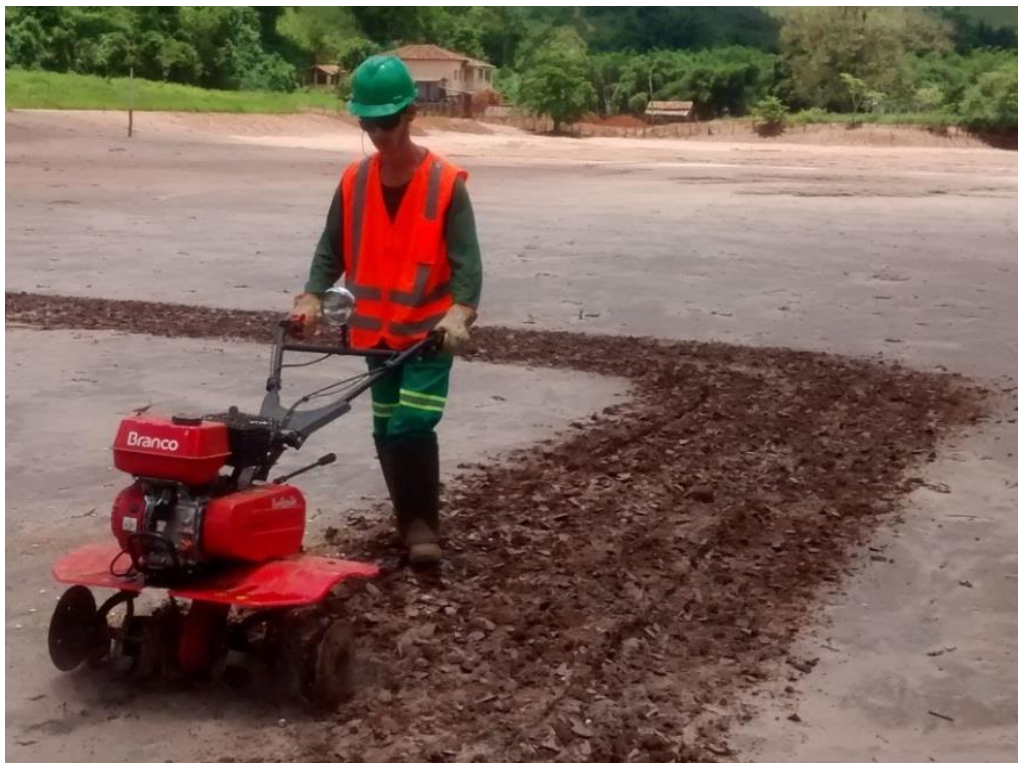
*Figure 41: Semi-mechanized preparation of the substrate using a motor-cultivator near Barra Longa.*

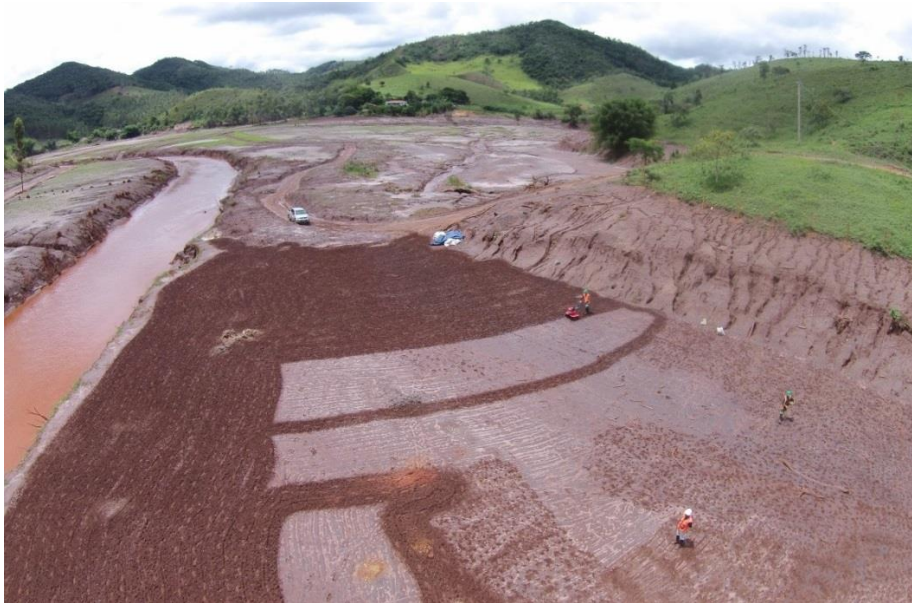
*Figure 42: Preparation of the soil utilizing manual and semi-mechanized methods of scarification of the substrate, seeding and fertilization being executed near Paracatu de Baixo*
