**Updated Integrated Environmental
Recovery Plan
PRAI**

January 2017

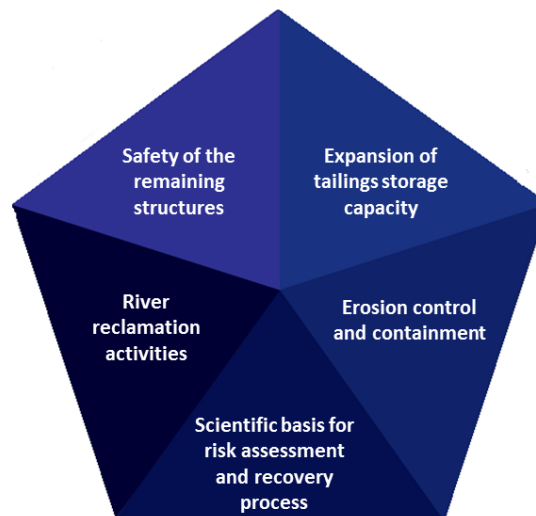
Figure 1 presents the integrated activities required over the short and medium range in order to reduce the risks and impacts of the coming rainy season and conclude the technical and scientific evaluations necessary to provide a basis for the full and integrated approach to river reclamation.

Figure 1: Consolidated view of the strategy adopted by Samarco for environmental recovery.

As shown in Figure 1, the areas of primary focus for execution in the rainy season and in the short term are:

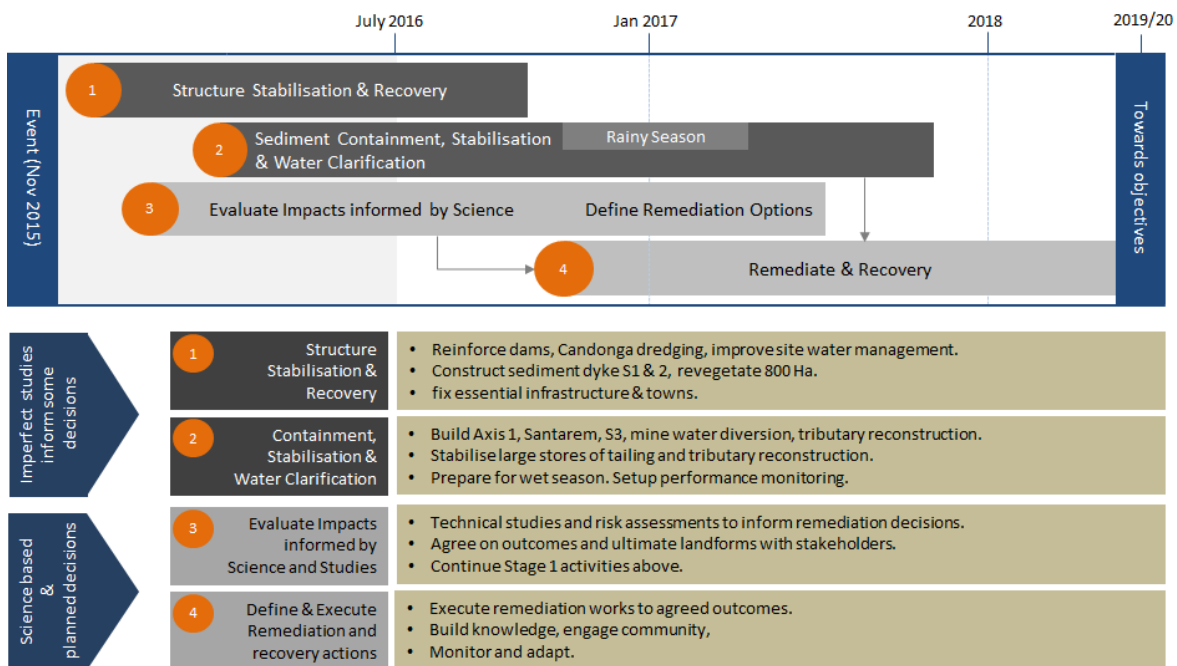
The chart below (Figure 2) shows the process adopted initially by Samarco and the continuity of the same which is being conducted by the Fundação Renova in the planning of the recovery actions, in the form of a timetable. It is important to observe the separation that exists between the actions:

Figure 2: Timeline of the strategy adopted by Samarco and Fundação Renova for environmental recovery.

Figure 2 shows the timetable of the Fundação Renova and of Samarco for the main actions related to the three main axes:

Figure 2 presented the process of execution of these phases and shows the connections among the various actions in the initial stage, which are thoroughly detailed in this report, as well as the assessment

Figure 2 also presents the environmental recovery actions along the Gualaxo do Norte, Carmo and Doce rivers. The priority actions for the next rainy season are in progress or in an advance stage of planning. The integrated medium and long term planning for all of the affected areas is in the initial phase of development.

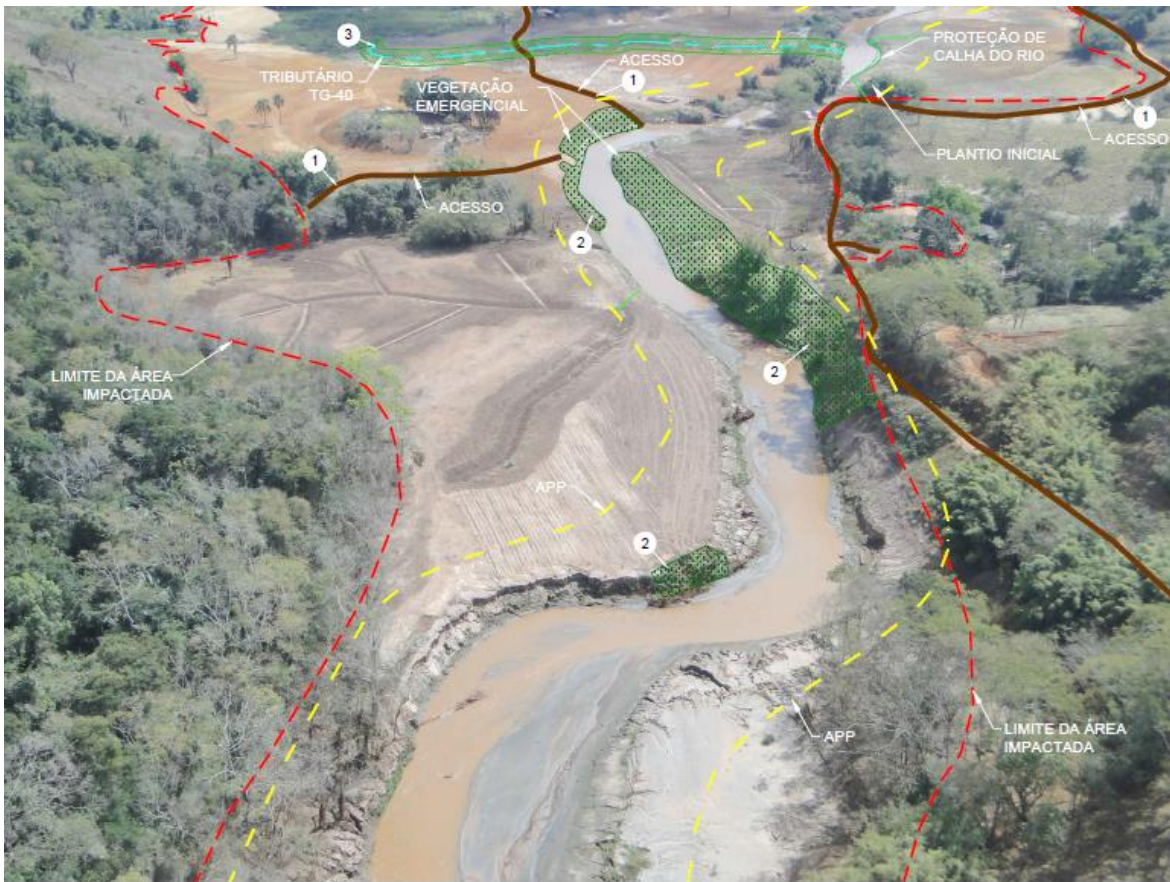
- 1 - ACESSOS
- 2 - VEGETAÇÃO EMERGENCIAL
- 3 - RECUPERAÇÃO DOS TRIBUTÁRIOS

Figure 3 – Schematic representation of the steps 1 to 3 of the environmental recovery.

1. Creation / recovery of accesses (completed);
2. Initial ground cover with grasses and leguminous species (complete, currently receiving maintenance);
3. Recovery of the tributaries (in progress – 58 recovered of 92 mapped out);
4. Reconfiguration and control of erosion of the plains (in progress);
5. Regularization of the river banks (in progress);
6. Revegetation of the river banks and plains (to be performed after the execution of items 4 and 5);
7. Planting of agriculture (to be performed after the execution of item 4);
8. Planting of riparian forest (to be performed after the execution of item 6).

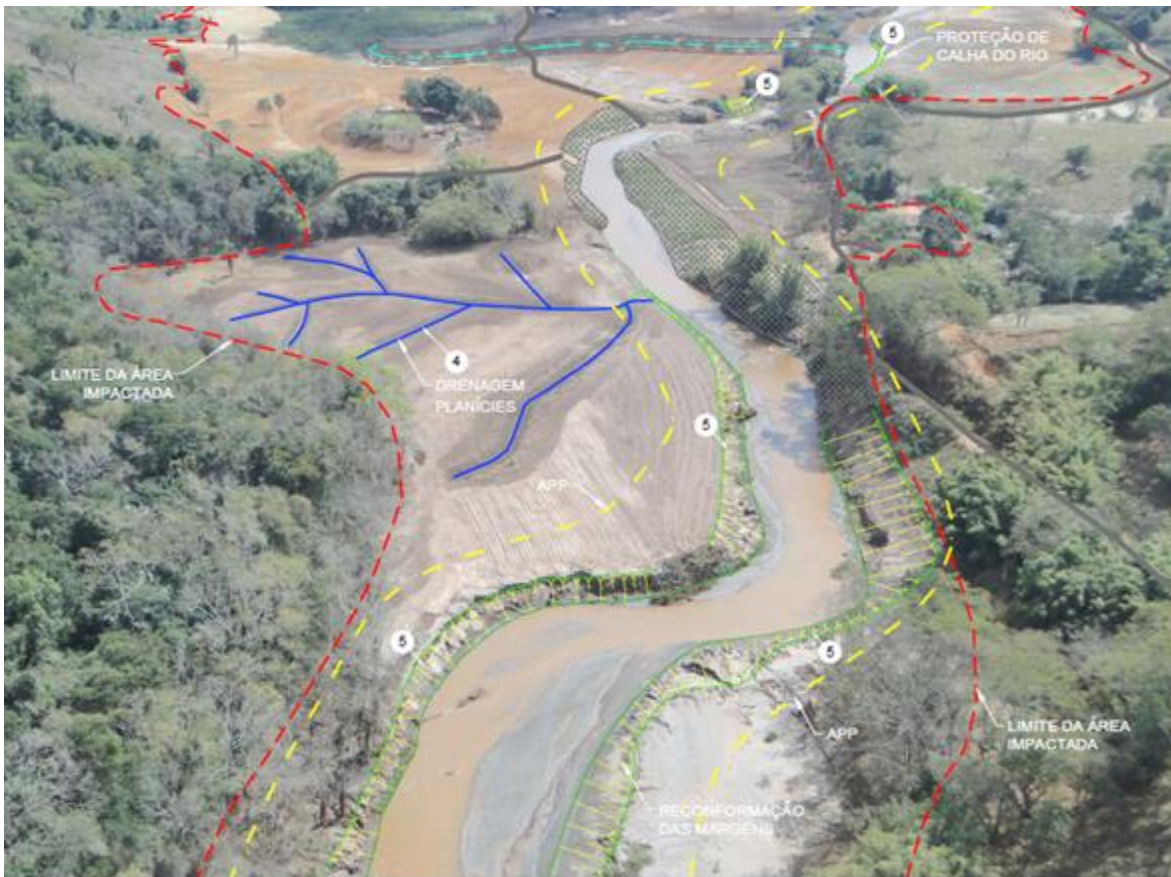
- 4 – RECONFORMAÇÃO E DRENAGEM DAS PLANÍCIES
- 5 – RECONFORMAÇÃO DAS MARGENS DOS RIOS

Figure 4 – Schematic representation of the steps 4 and 5 of the environmental recovery.

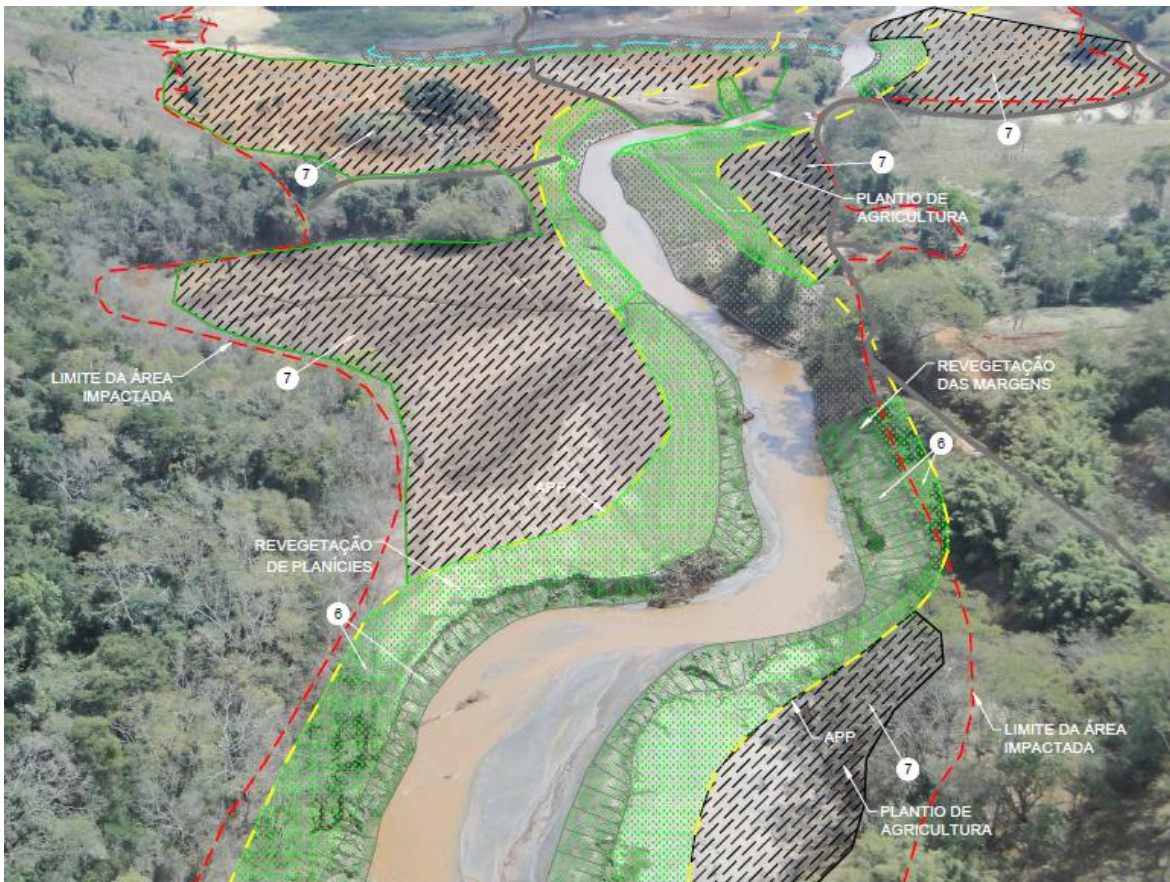
- 6 – REVEGETAÇÃO DAS MARGENS E PLANÍCIES
- 7 – PLANTIO AGRICULTURA

Figure 5– Schematic representation of the steps 6 and 7 of the environmental recovery.

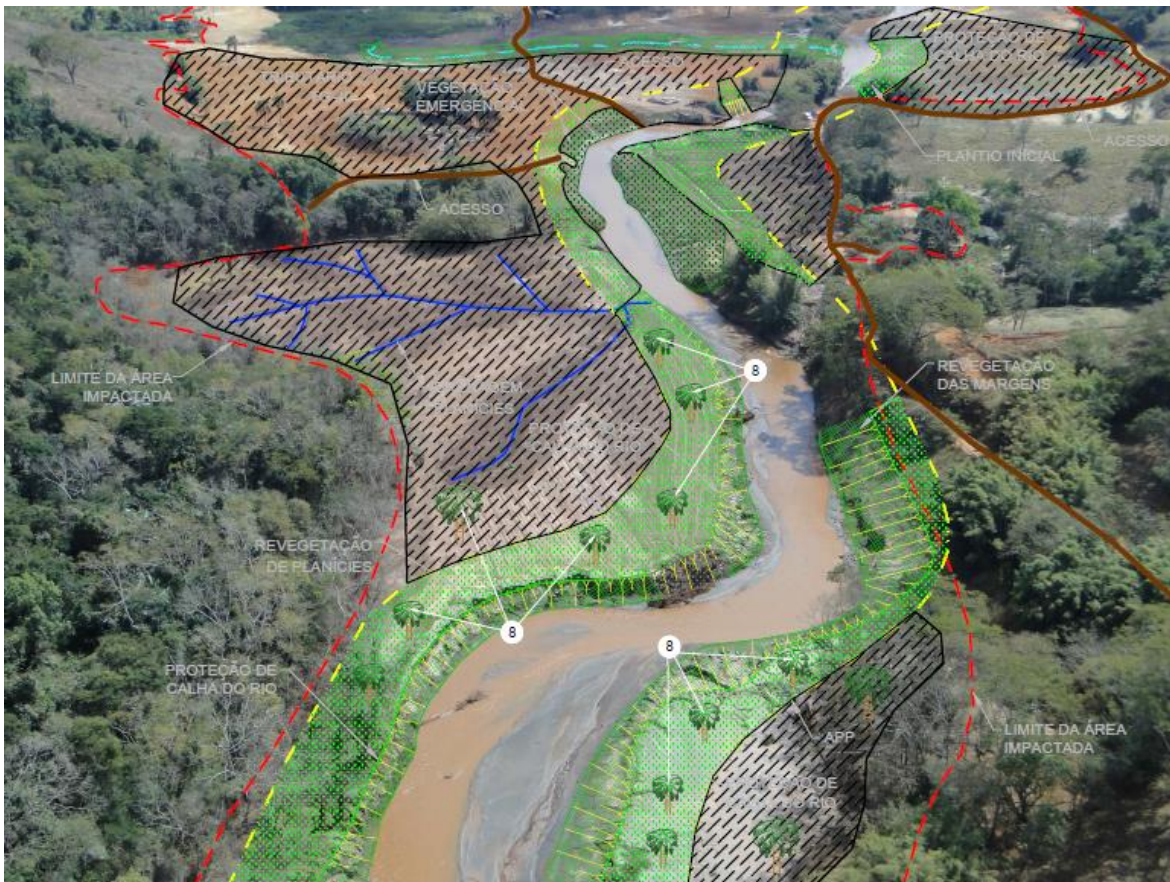
8 – PLANTIO DE MATA CILIAR

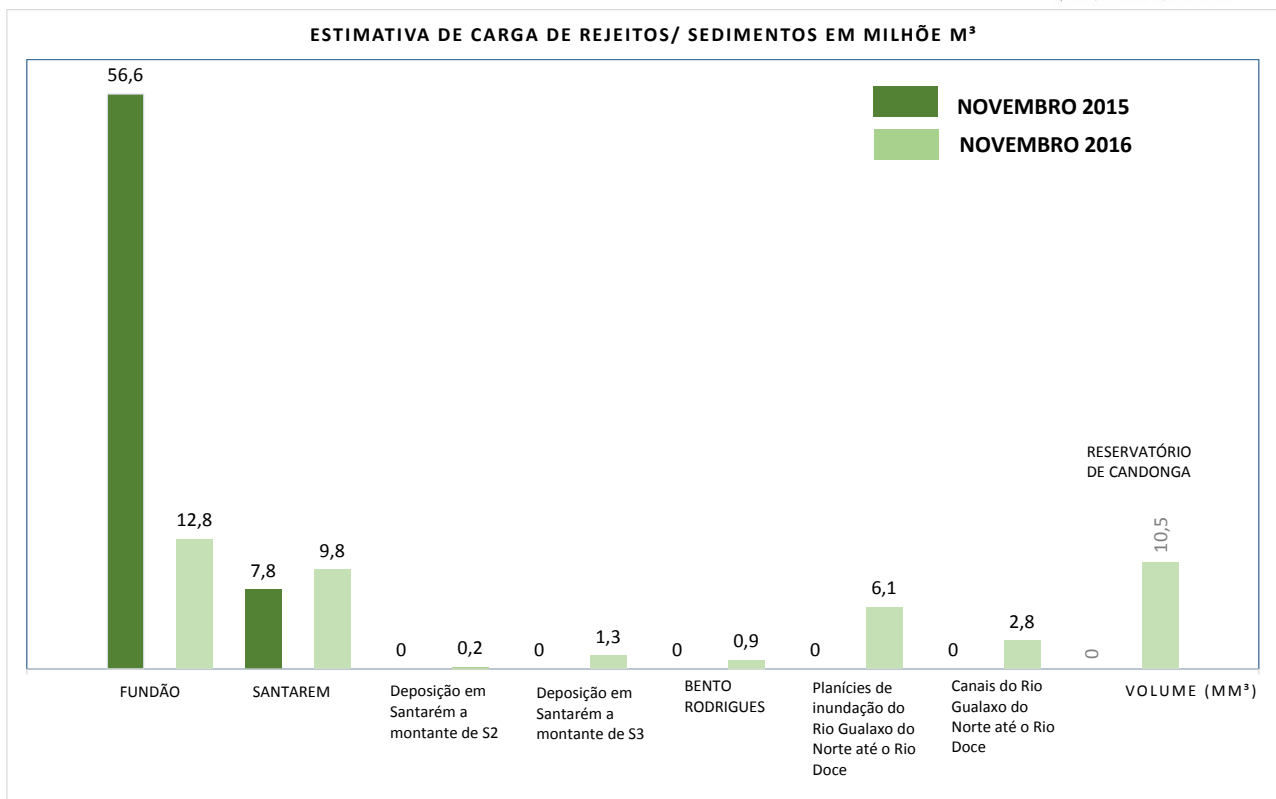
Figure 7 – Estimate of tailings/sediment load in millions of m³ (Source: Golder, RT-023_159-515-2282, Attachment Section 5.0).

Table 1 and Figure 7 present a summary of the estimated tailings volume between the mine and the Candonga dam in July 2016.

Bento Rodrigues to Candonga – The volume of sediment deposited downstream as far as Candonga is estimated at 8.9 Mm³, of which approximately 2.8 Mm³ are considered as movable and subject to re-entrainment and transport. Large deposits of sediments are found in the flood plains. Golder identified the main points of deposition (document nº RT-023_159-515-2282, See Attachment Section 5.0).

Candongá – The Candonga dam served as an important containment barrier, retaining a large quantity of the sediments flowing downstream. After the event, the volume of tailings is now 10.5 Mm³ (document nº RT-023_159-515-2282, See Attachment Section 5.0).

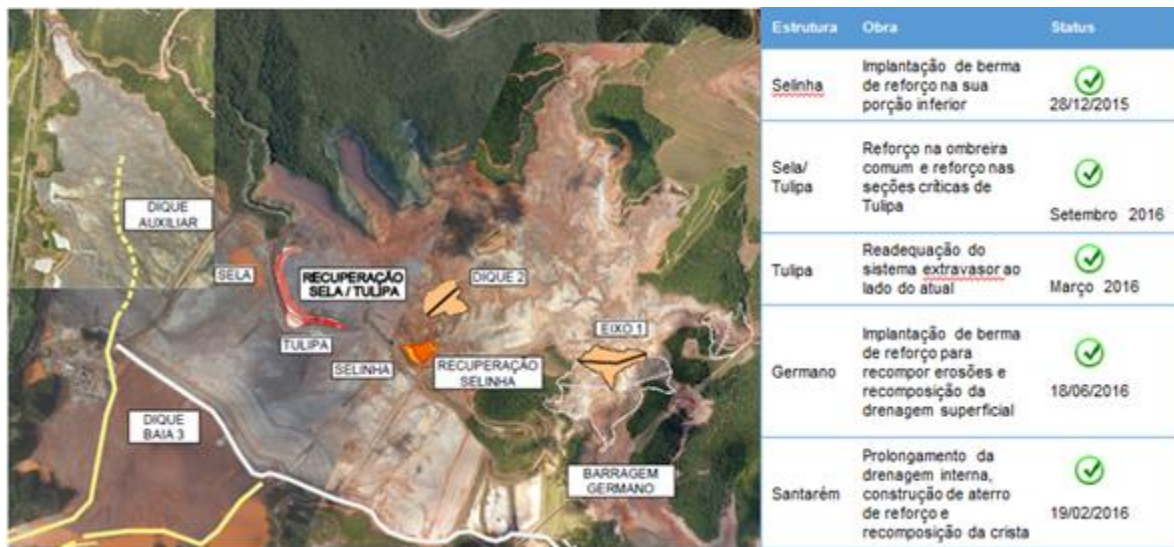
Figure 8 presents a summarized form of the status of the works of reinforcement executed on the remaining structures of the Germano complex.

Figure 8 : Emergency works of containment and stabilization executed during the rainy period 2015/2016

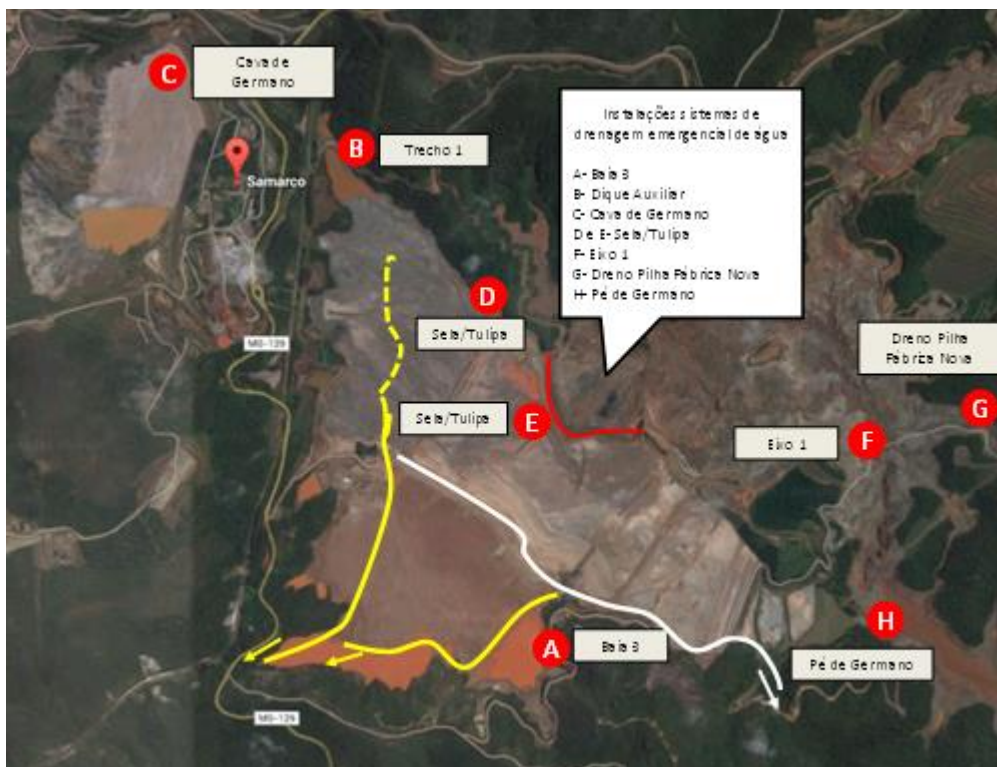
The measures already implemented are listed in Figure 9.

Figure 9: Location of the installed pumping systems – Red Points.

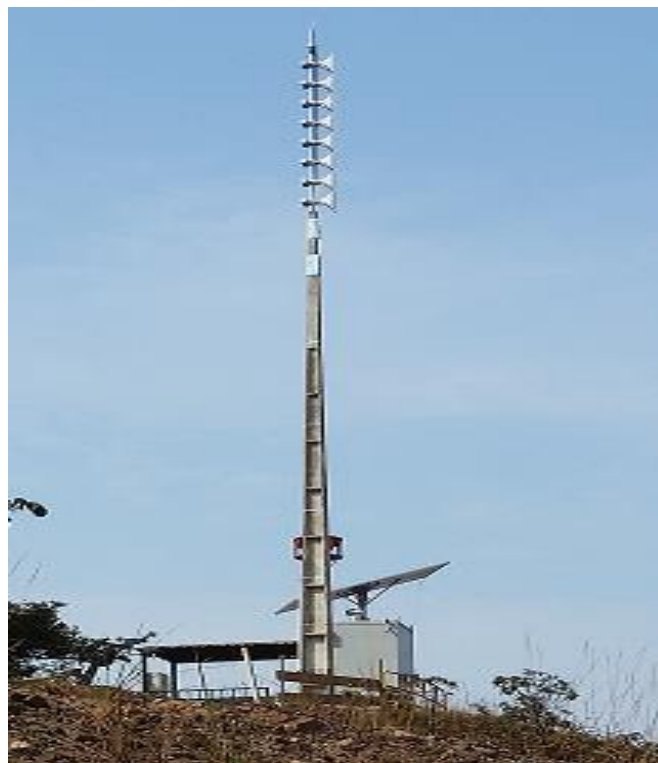
The system was specified with long-range sirens (Pavian model) meeting the requirements FEMA (Federal Emergency Management Agency) as described below:

- Sound power to range up to 2,000 meters;
- 70dB minimum acoustic power at the edge of the coverage area;
- Possibility of emitting beep tones and loudspeaker;
- Communication with control unit by two or more media;
- Control unit with drive data log (Vektra); and
- Self testing of multiple siren System.

Figure 10: Long Range Sirens.

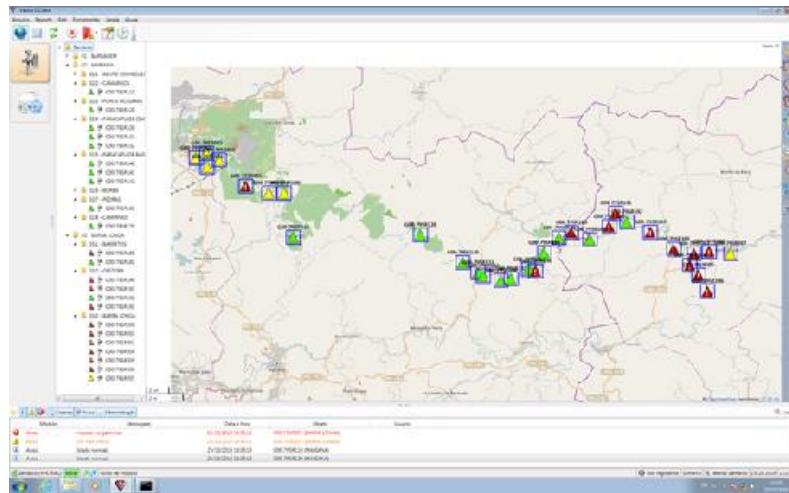
Figure 11: Command center with activation data log (Vektra).

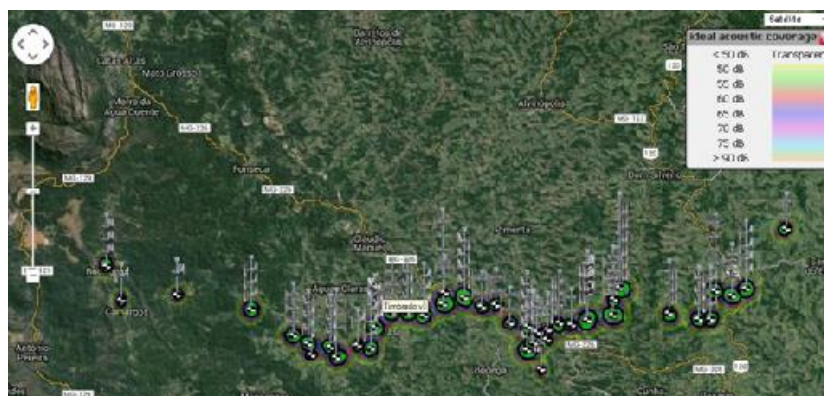
To meet the needs of the areas of self rescue as well as the communities of Mariana and Barra Longa, the following sirens will be required: 31 (thirty-one) sirens distributed as follows, 5 in Dams areas, 2 in Bento Rodrigues, 1 in Camargos, 1 in Ponte do Gama, 3 in Paracatu de Cima, 3 in Paracatu de Baixo 1 in Borba, 1 in Pedras, 1 in Campinas, 2 in Barretos, 4 in Gesteira and 7 in Barra Longa.

Figure 12: Overview of all Sirens

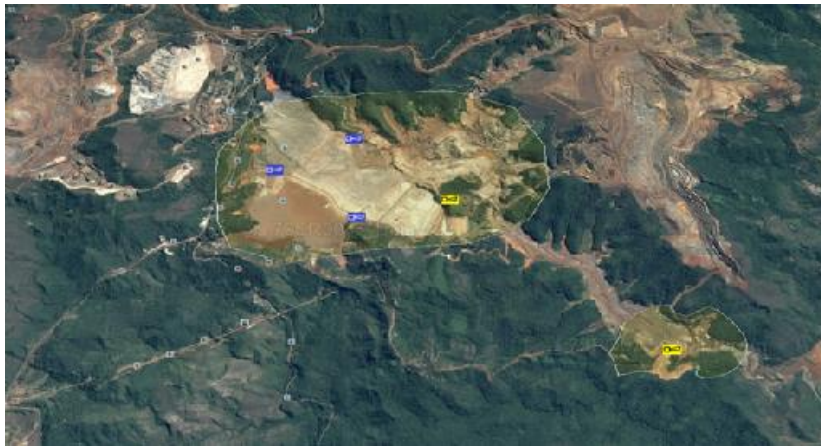
Figure 13: Sirens of the Germano and Santarém dams .

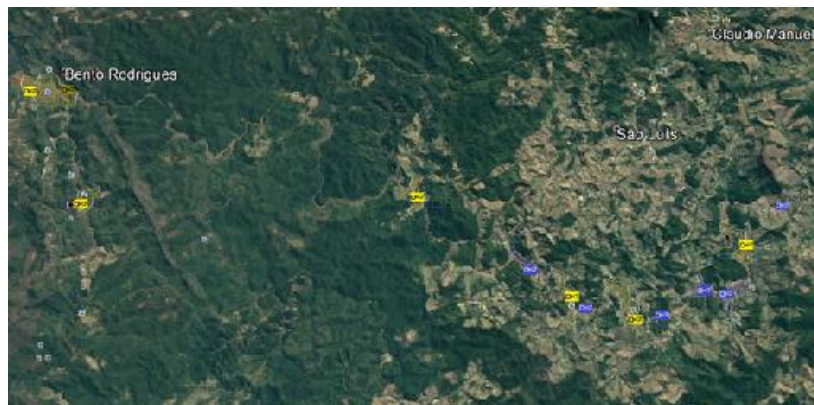
Figure 14: Sirens of the Communities of Mariana

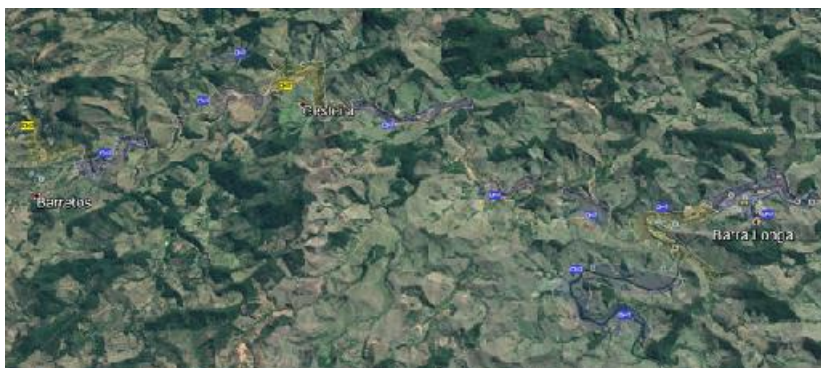
Figure 15: Sirens of the Barra Longa communities.

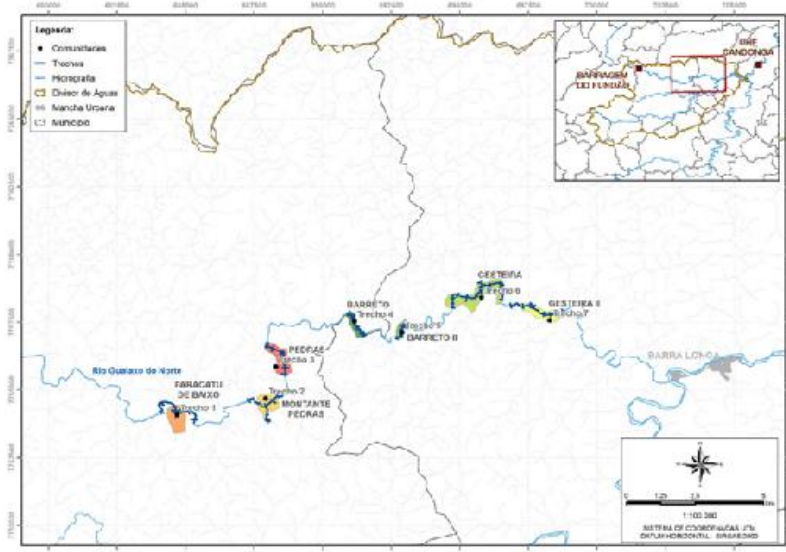
Renova Foundation is implementing the warning system against floods in the basin of the Carmo river, specifically for the riverside towns of the Gualaxo do Norte river and the urban area of the city of Barra Longa - MG, which is based on prior knowledge of the occurrence of precipitation events, in terms of intensity and spatial and temporal distribution, as well as the likely response of the basin to these events, in terms of generating flows and possible floods in river stretches of interest.

Figure 16: Areas and stretches of Rivers for the warning system against floods.

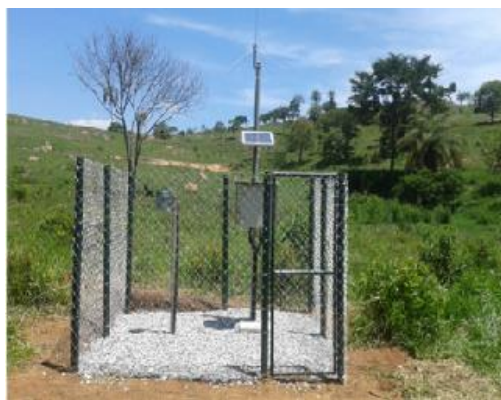
The hydro-meteorological network to be deployed will initially be comprised of five (5) Automatic linigraphic stations and eight (8) Automatic pluviograph stations with real-time data transmission, distributed along the Carmo river basin, as well as installing conventional linimetric sections along the Gualaxo do Norte river basin, in the passages of interest shown in the Figure above. As far as possible, existing installations of the official network of the National Water Agency will be used - ANA - optimization services.

Figure 17: Pluviographic station and data logger

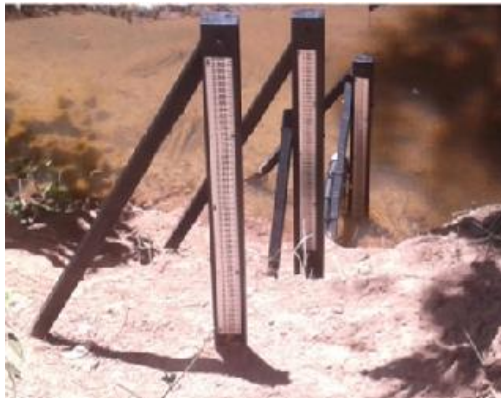
Figure 18: Linimetric Section and automatic level sensor

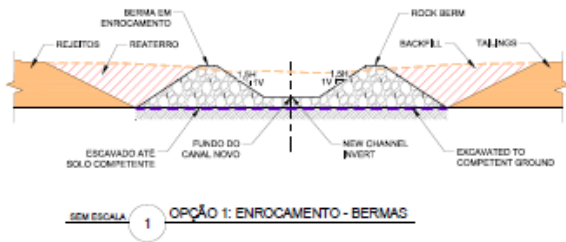
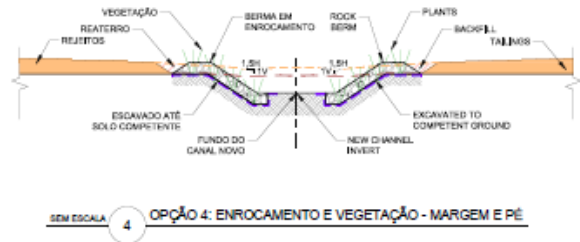
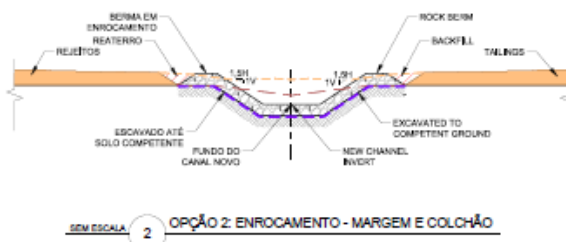
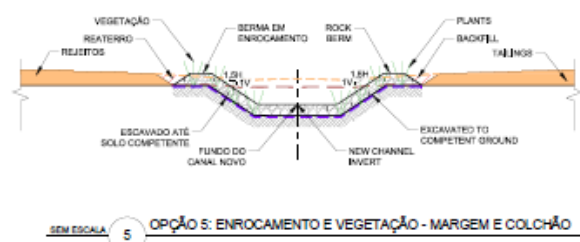
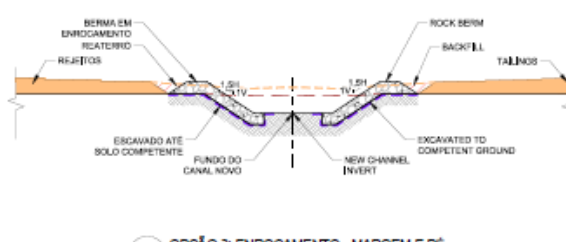
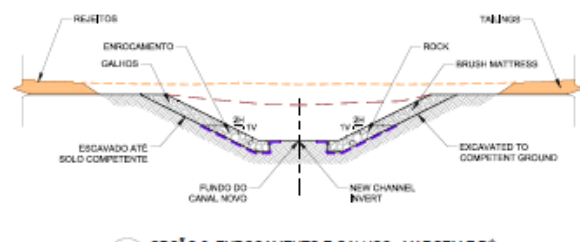
Figure 19: Typical Options of bio-engineering – Options 1 to 6 (Golder Associates - G006900-C-100024_R-01, see Attachment Section 7.3).

The types of recovery assessed are listed below and include a combination of the proven methods and the alternative methods of bio-engineering, according to Li & Eddlemen (2002). With this, 12 typical sections were defined to be adopted in the recovery of the tributaries. Figures 19 and 20 illustrate the schematic drawings of each typical section.

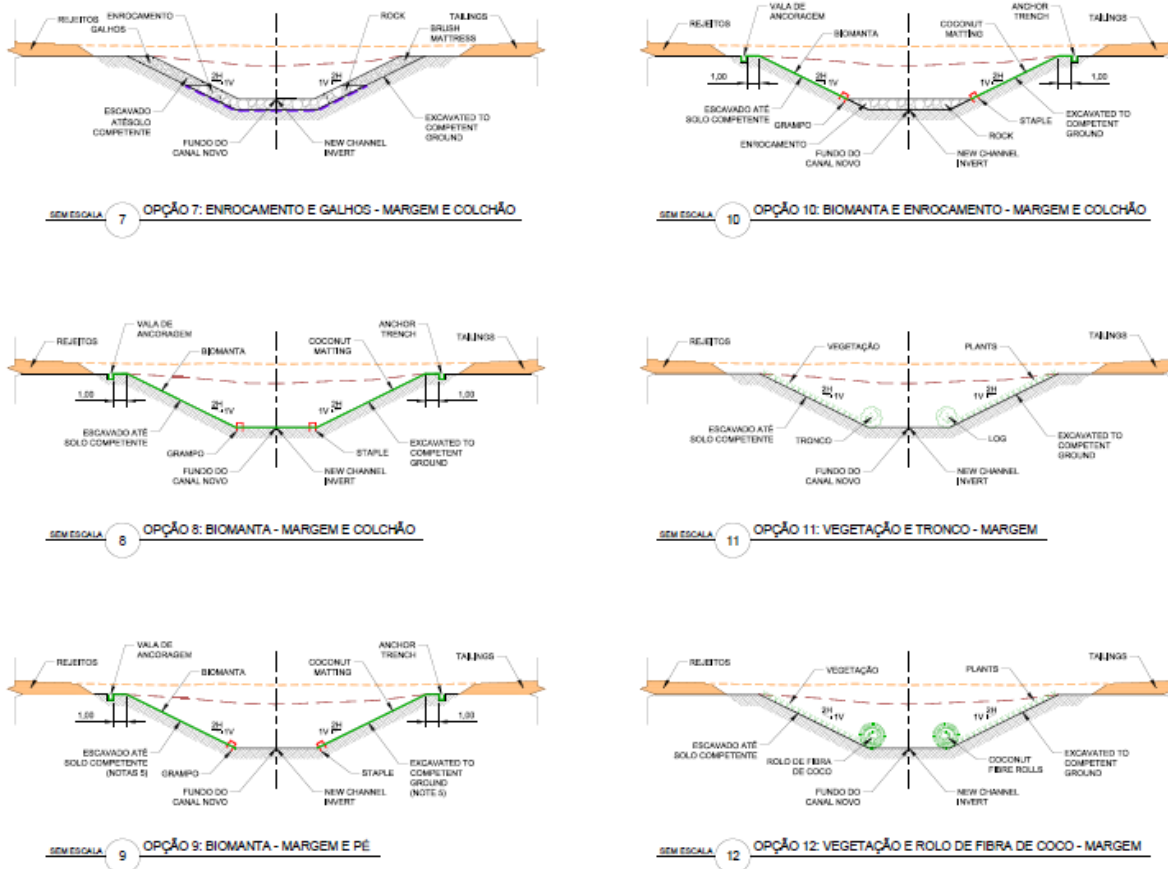
Figure 20: Typical Options of bio-engineering – Options 7 to 12 (Golder Associates - G006900-C-100025_R-01, see Attachment Section 7.3).

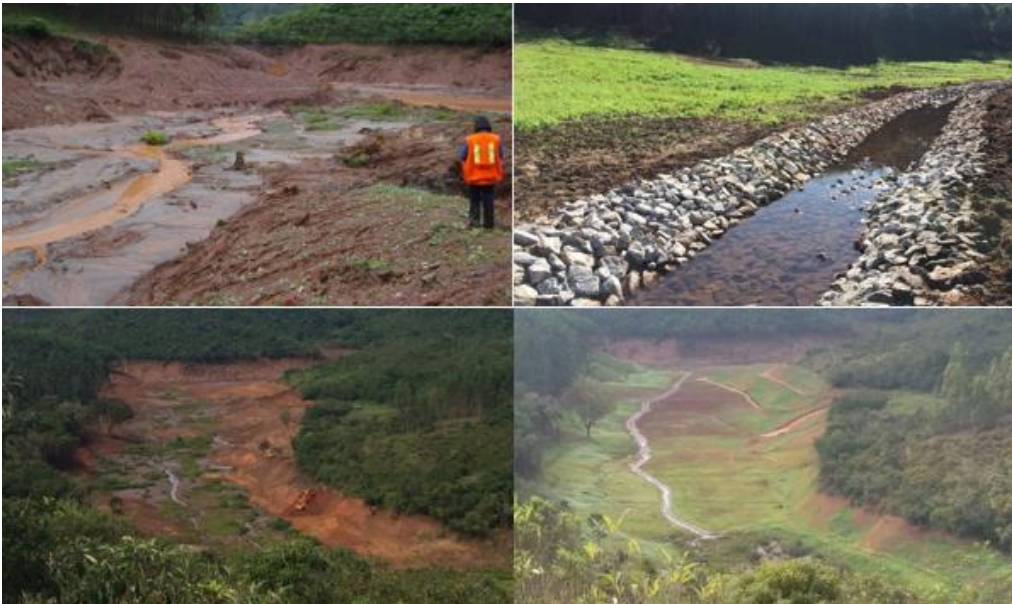
Tributary 5 of the Gualaxo do Norte River (TG05)

Figure 21: Environmental recovery of the tributary TG05.

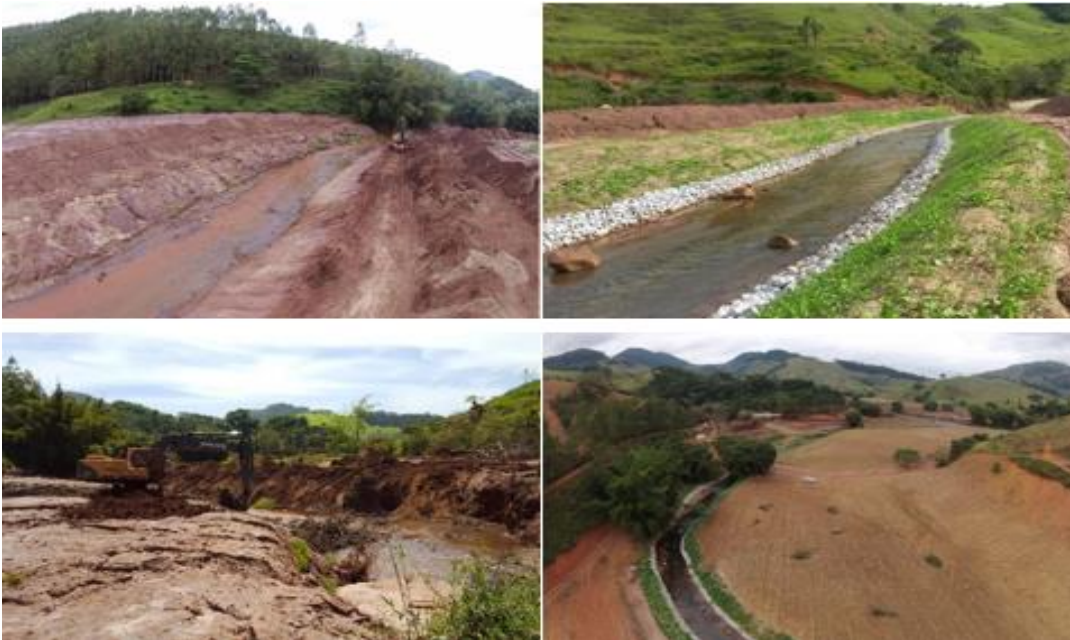
Tributary 49 of the Gualaxo do Norte River (TG49)

Figure 22: Environmental recovery of the tributary TG49.

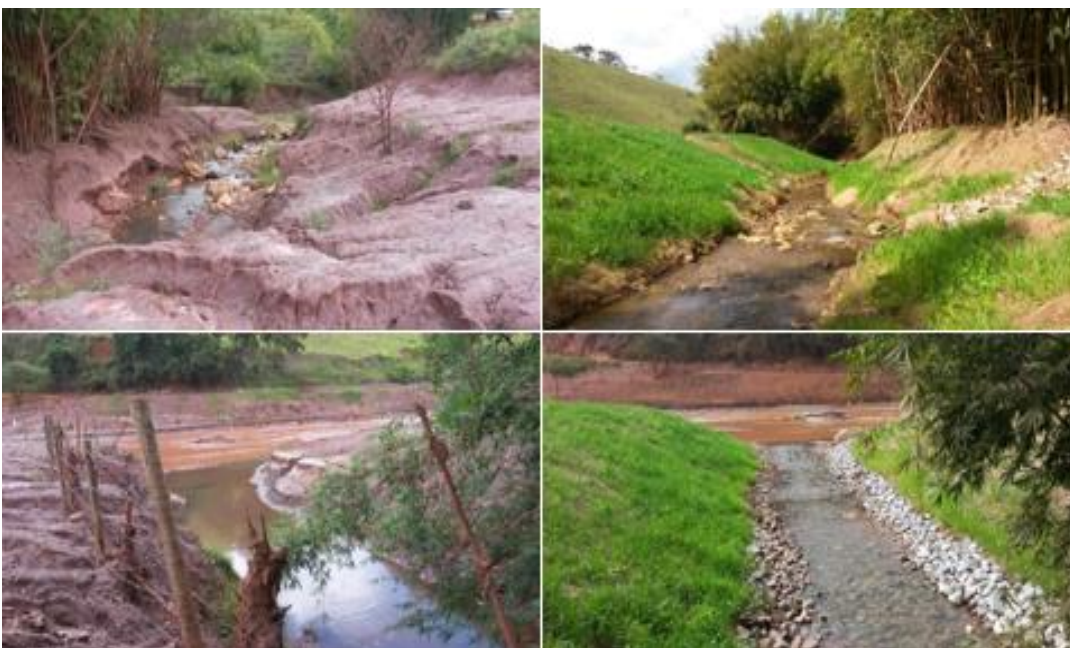
Tributary 51 of the Gualaxo do Norte River (TG51)

Figure 23: Environmental recovery of tributary TG51.

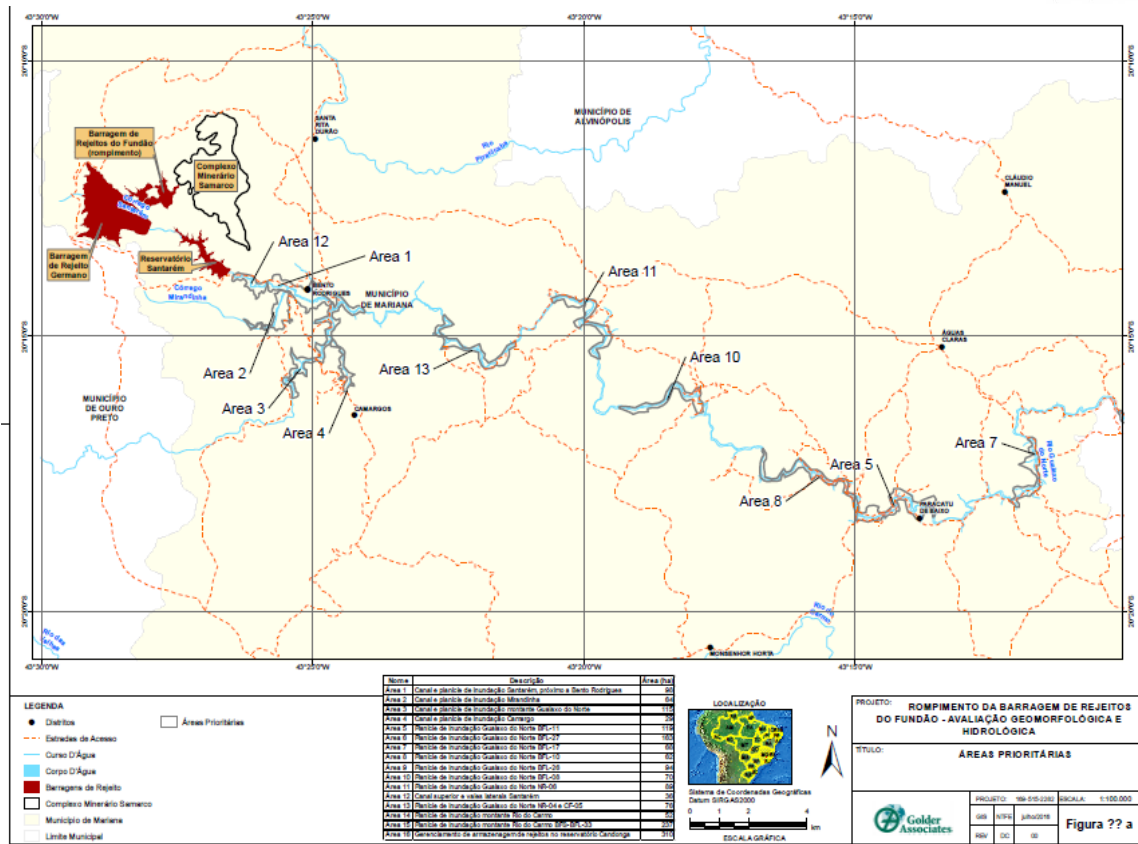
The company Golder Associates is responsible for the development of the engineering designs of reconfiguration of the channels of the main rivers and of the control of erosion in the areas impacted. For emergency response for the next rainy season, 12 areas contemplated in the geo-morphologic study were defined as priority. The next figure presents the areas to be prioritized. The areas 12 and 16 are not included in the scope of this work since the S4 Dike is being installed in area 12 (plain area located near Bento Rodrigues), which will have its environmental recovery concluded after the decommissioning of the dike and the area 16 (Candongá) is being dredged for removal of the deposited sediments. The Area 1 is an area which will be flooded with the pumping of water and sediments coming from Dike S3. The Area 2 is the area of inundation of the district of Bento Rodrigues, after the execution of the S4 Dike works.

Figure 24: Priority Areas – Part 1.

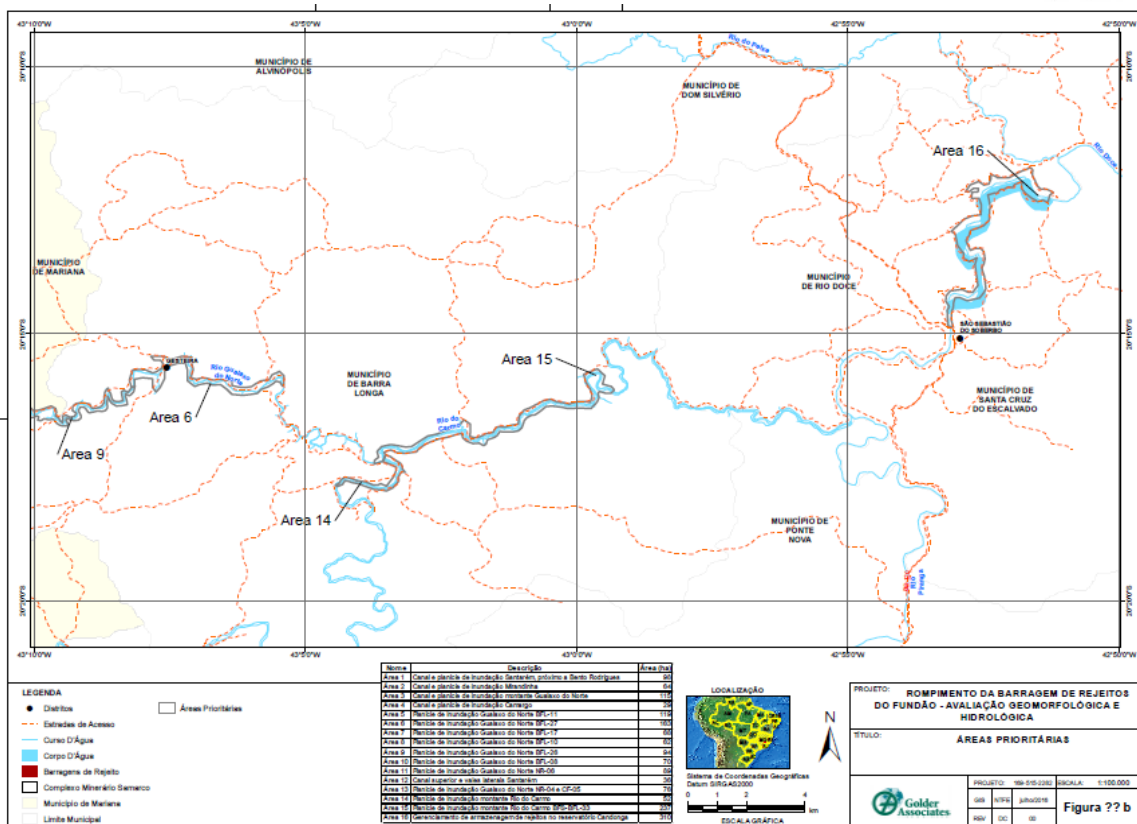
Figure 25: Priority Areas – Part 2.

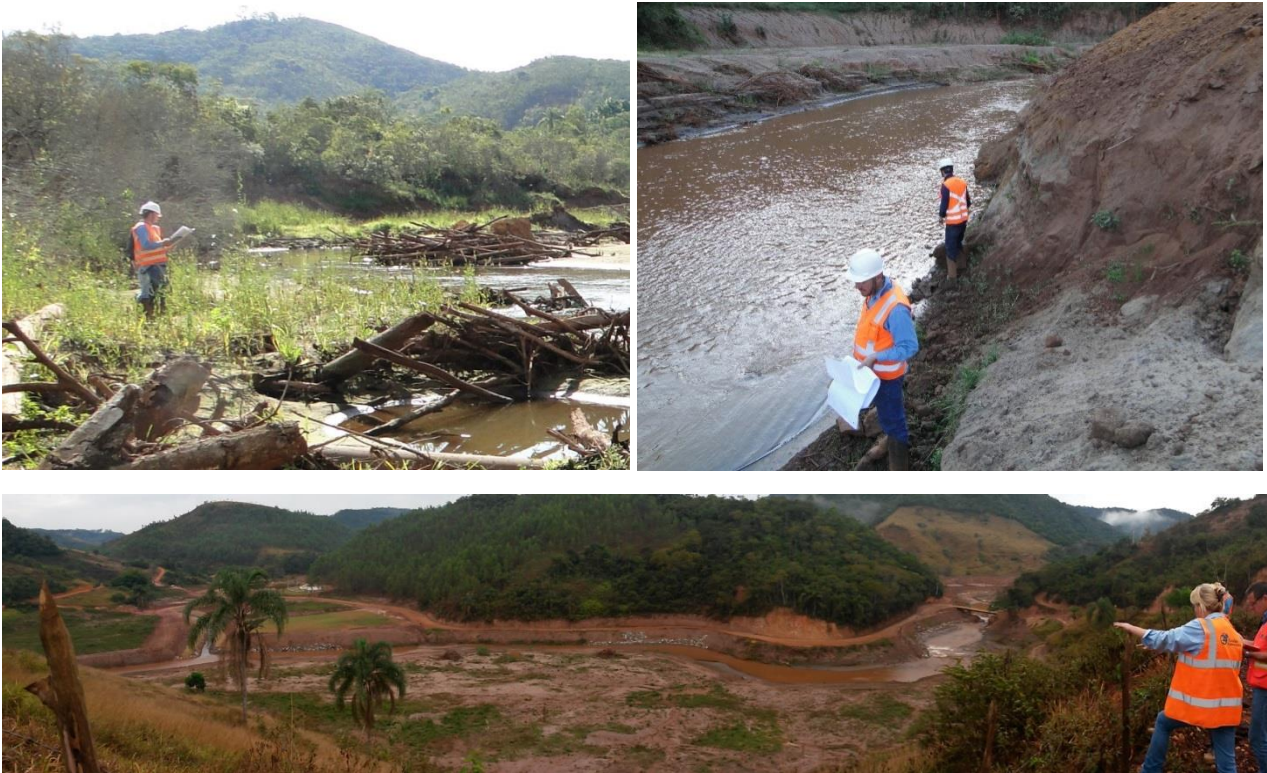
The field survey had as its objective to assess all of the areas contained in the scope of work, collecting photos and information relevant to the development of the initial designs of the priority areas. This survey permitted the identification of typical engineering solutions, or that is to say solutions which may be

applied commonly for the majority of the areas visited. See below some photos of the field work done by the Golder team.

Figure 26 Survey executed by the team in the field

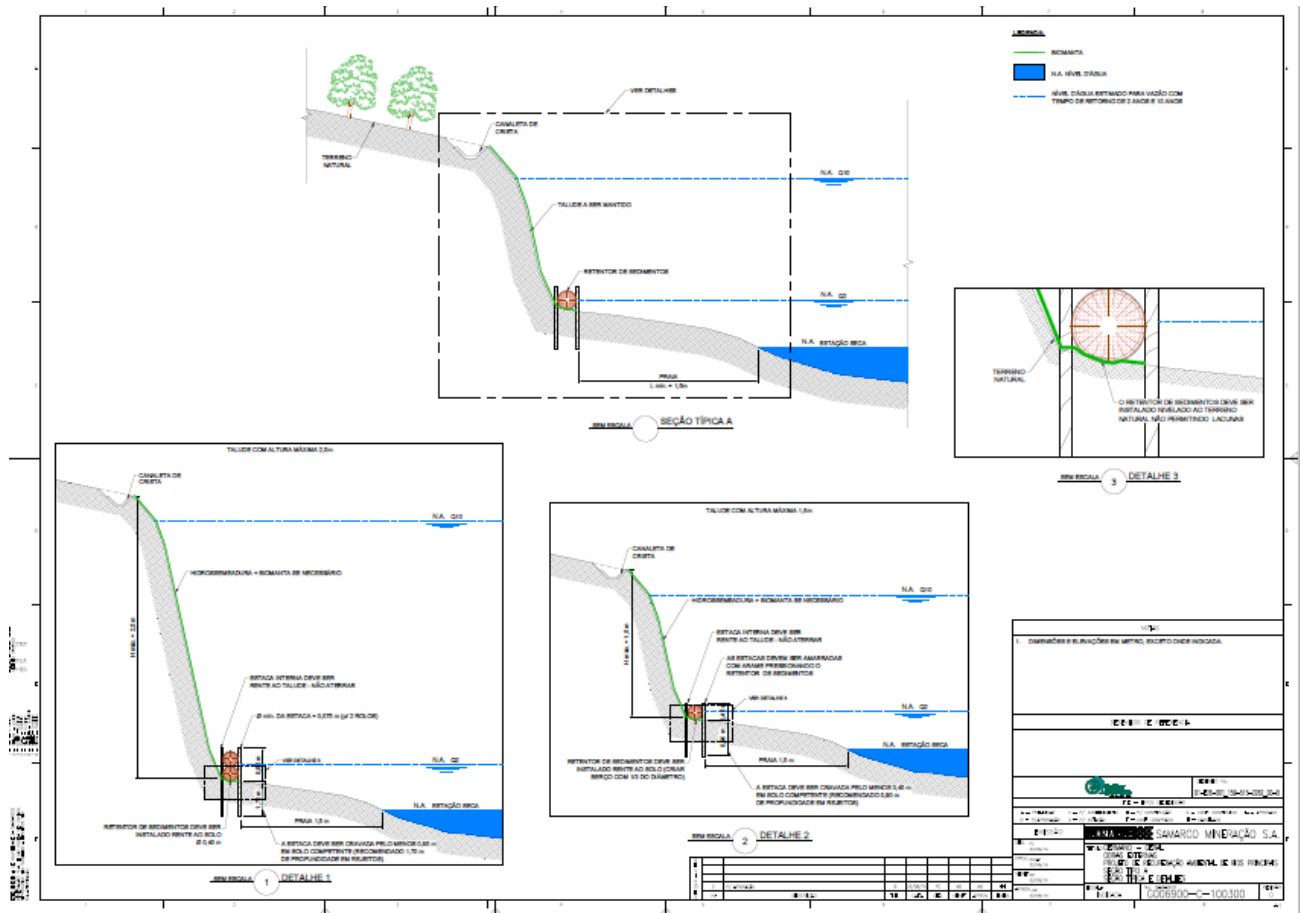
Figure 27: Section TYPE A schematic.

- TYPE A: Bank exposed with the presence of beach (Figure 27);
- TYPE B: Bank exposed without the presence of a beach (Figure 28);
- TYPE C: Bank exposed with high embankment and intermediate bench (Figure 29);

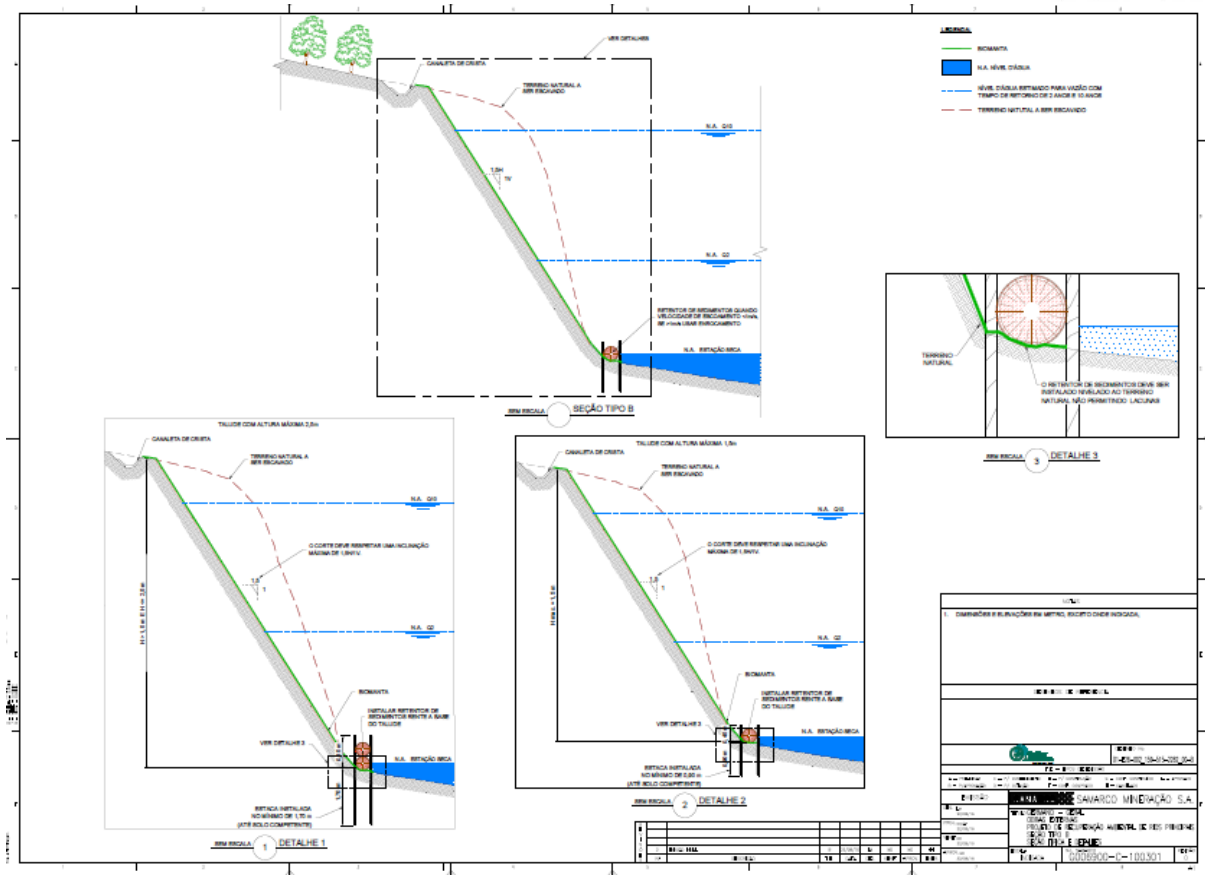
Figure 28: Section TYPE B schematic.
