**Updated Integrated Environmental
Recovery Plan
PRAI**

January 2017

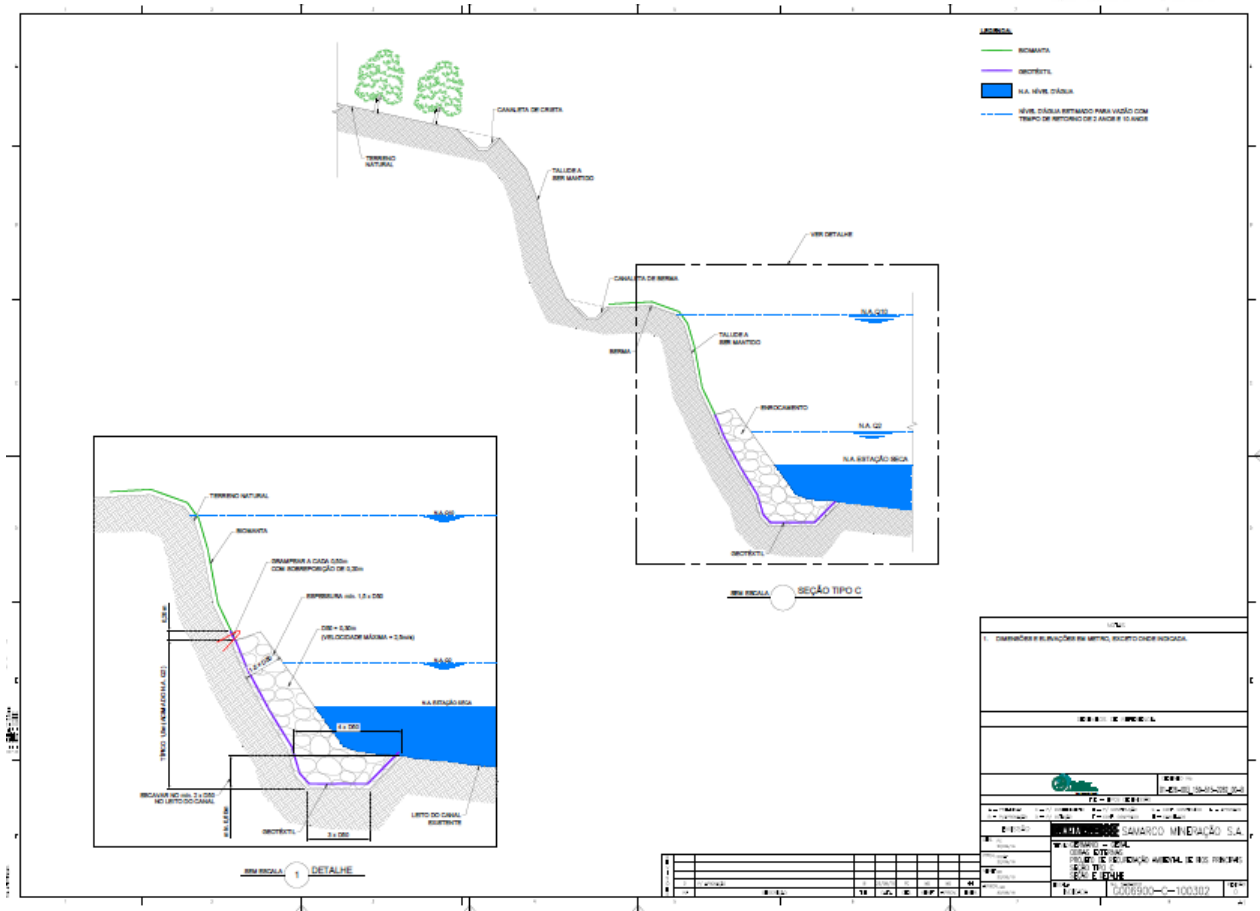
Figure 29: Section TYPE C schematic.

- TYPE A: Bank exposed with the presence of beach (Figure 27);
- TYPE B: Bank exposed without the presence of a beach (Figure 28);
- TYPE C: Bank exposed with high embankment and intermediate bench (Figure 29);

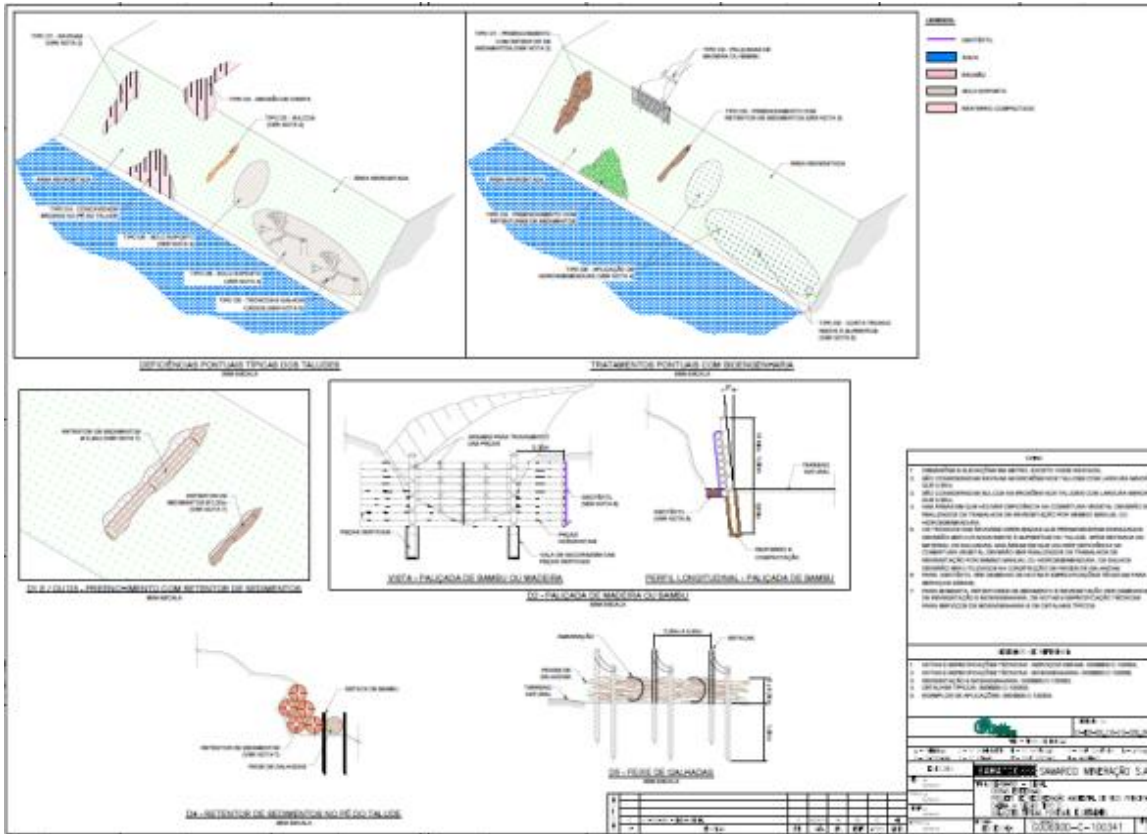
Figure 30: Section TYPE D Schematic

- TYPE D: Stabilized bank where the need will be assessed of the application of specific measures for the containment of erosion and reinforcement of vegetation (Figure 30); and
- TYPE E: Exposed bank, situation in which the sections type above are not applicable, thus requiring a specific design (Figure 31).

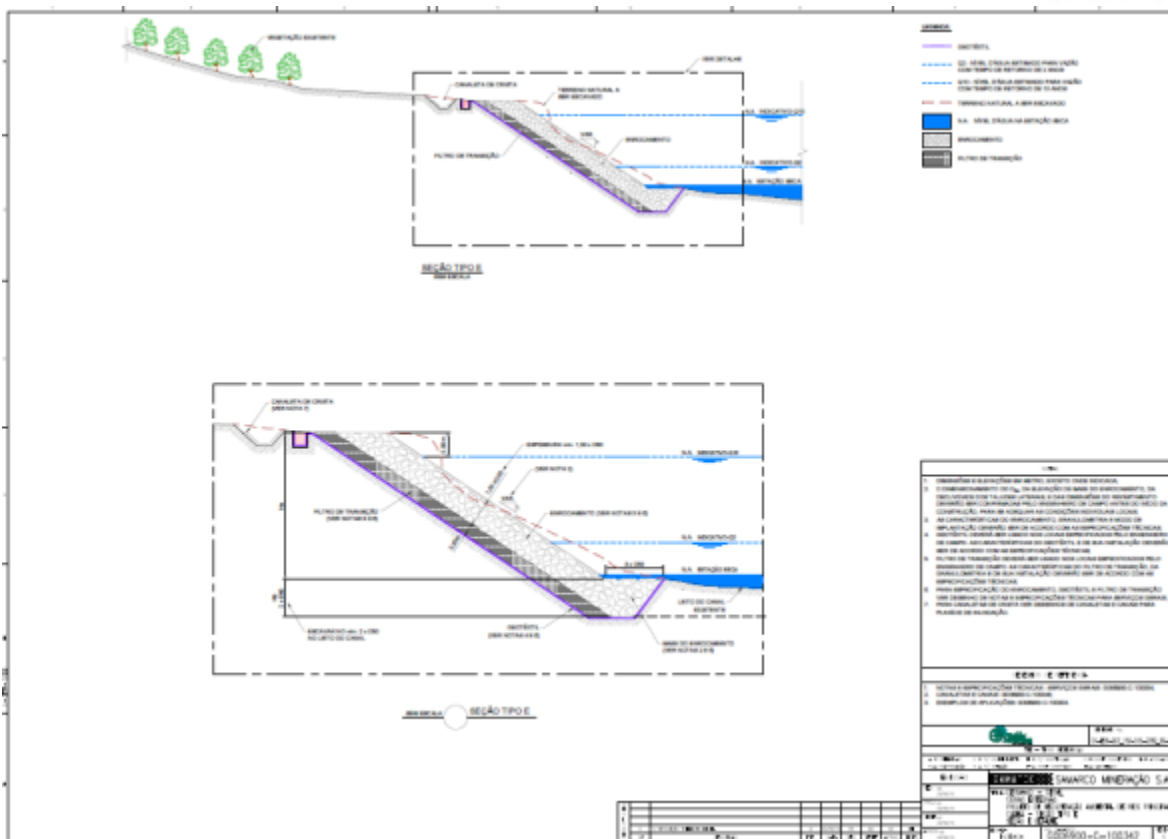
Figure 31: Section TYPE E Schematic.

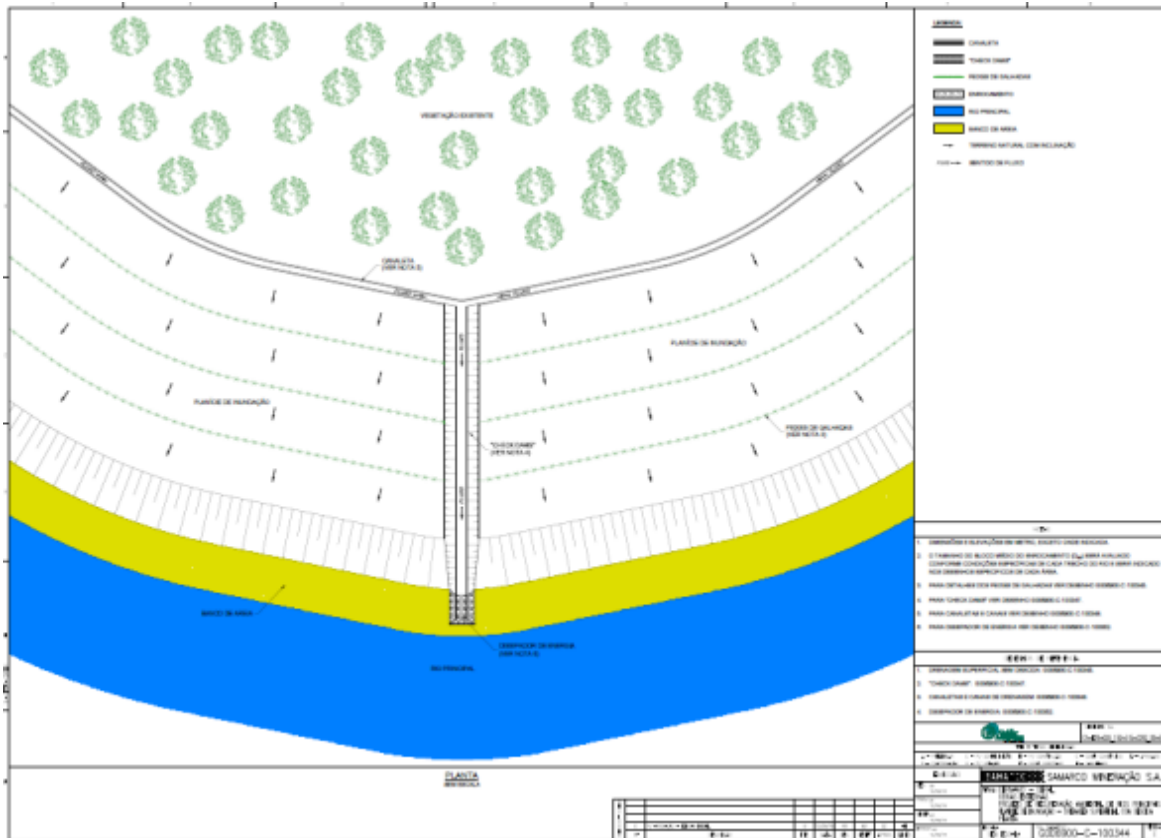
It is important to point out that all these structures offer a perfect synergy with the activities of subsequent re-forestation which are detailed in specific designs. Typical drawings follow below for erosion control.

Figure 32: Typical drawings of erosion control (1)

- Rain gutters with triangular and trapezoidal cross-sections in earth or lined with anti-erosive bio-blankets;
- Trapezoidal channels with dikes and sediment retainers;
- Windrows of protection in level;
- Contour ridges with sediment retainers, strips of branches and/or Vetiver Grass;
- Wooden or bamboo live crib-wall;
- Embankments with rock armouring;
- Energy dissipaters.

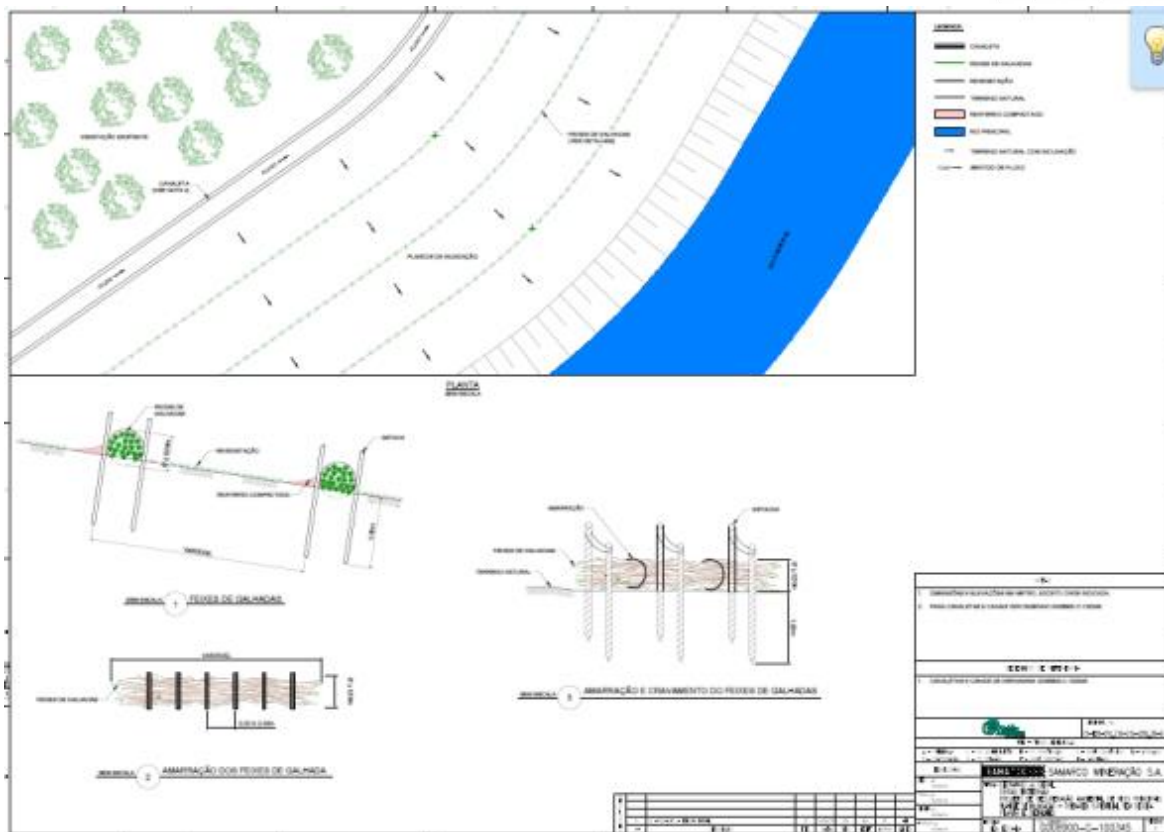
Figure 33: Typical drawings for erosion control (2)

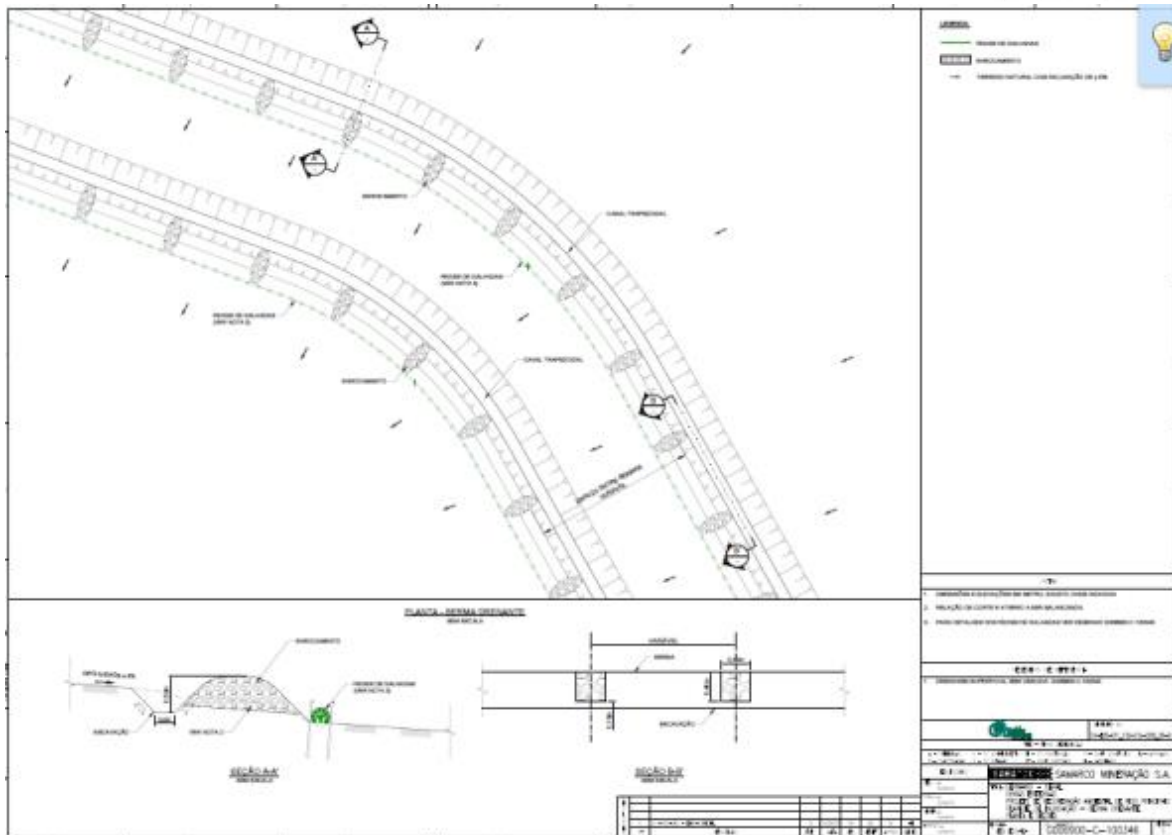
Figure 34: Typical drawing for erosion control (3)

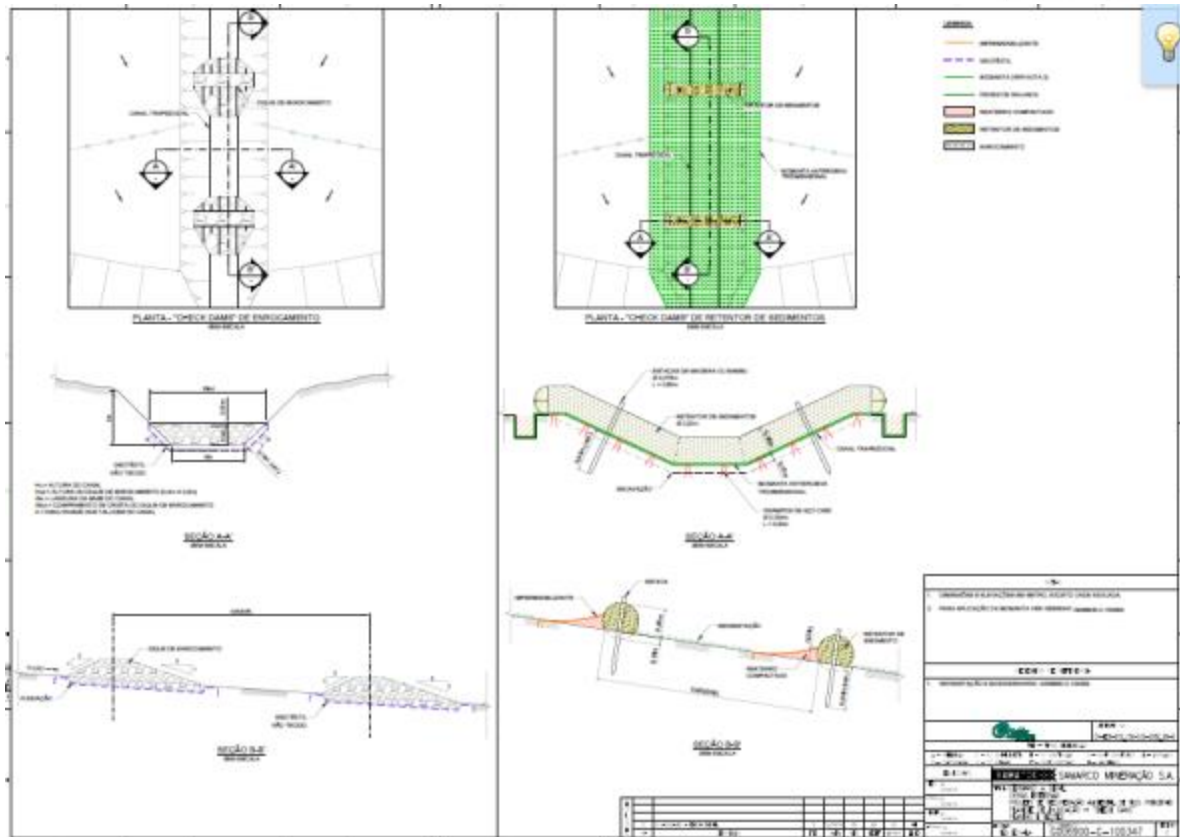
Figure 35: Typical drawing for erosion control (4)

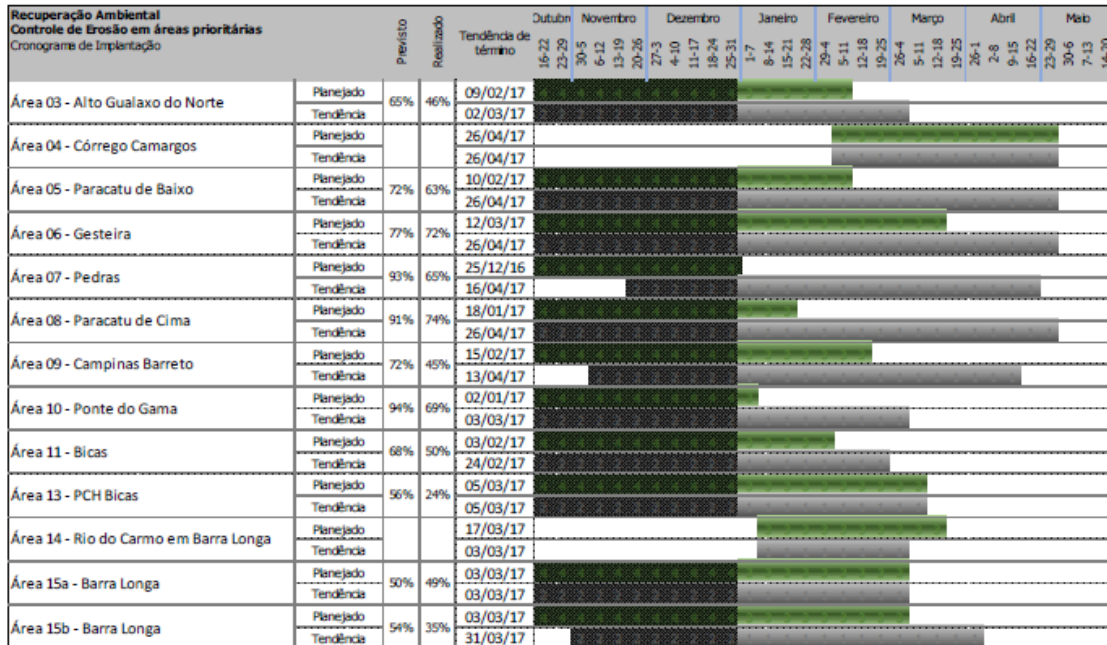
Cronograma áreas prioritárias

Avanço previsto: 67% Avanço realizado: 52%

Figure 38: Schedule of activities of reconfiguration of the river channels and erosion control

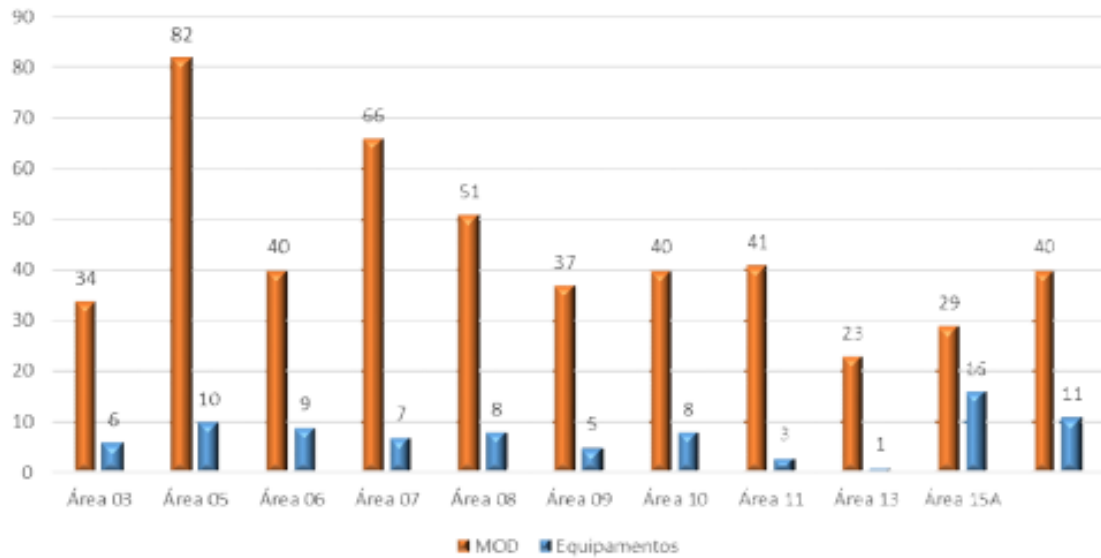
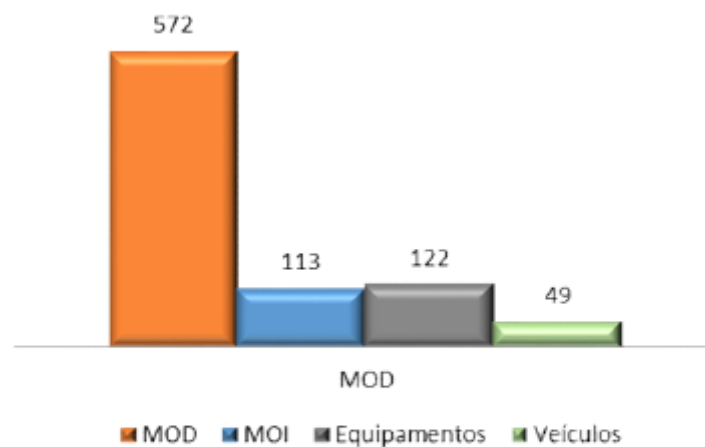
The histogram of equipment and labor are also shown below for activities of bio-engineering to meet the program needs.

Histograma de mão de obra direta e equipamentos por área prioritária

Histograma total de mão de obra considerando efetivo complementar que atende a tributários e equipes que atuam em todas as áreas

Figure 39: Histogram of labor and equipment for bioengineering works on the channels and banks of the impacted rivers

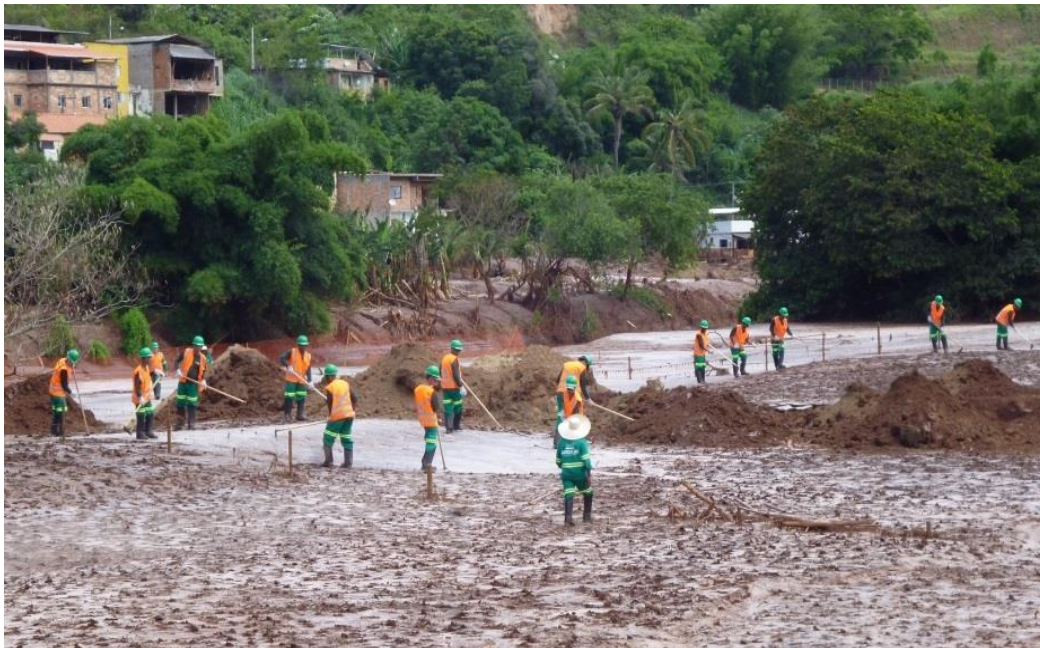
Figure 40: Manual micro planting holes of the soil using small hoes near Barra Longa.

The methods of scarification selected included the manual opening of micro planting holes with the use of small hoes or, where the substrate may be flat and firm, utilization of motor-cultivators (Figures 40, 41, and 42).

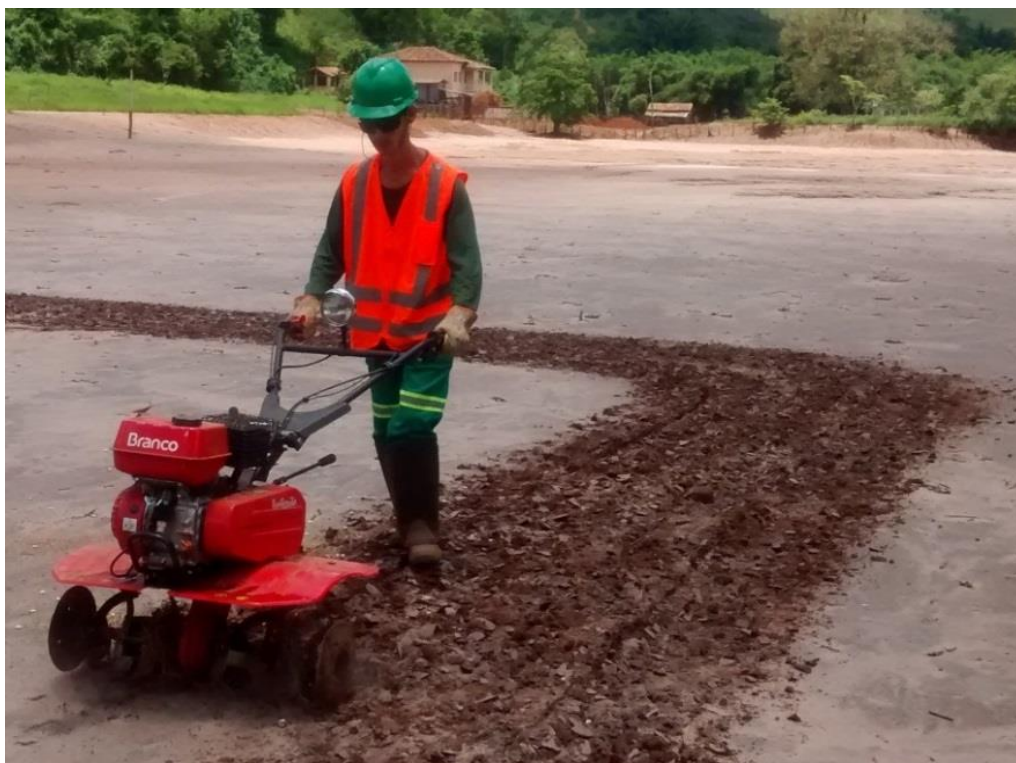
Figure 41: Semi-mechanized preparation of the substrate using a motor-cultivator near Barra Longa.

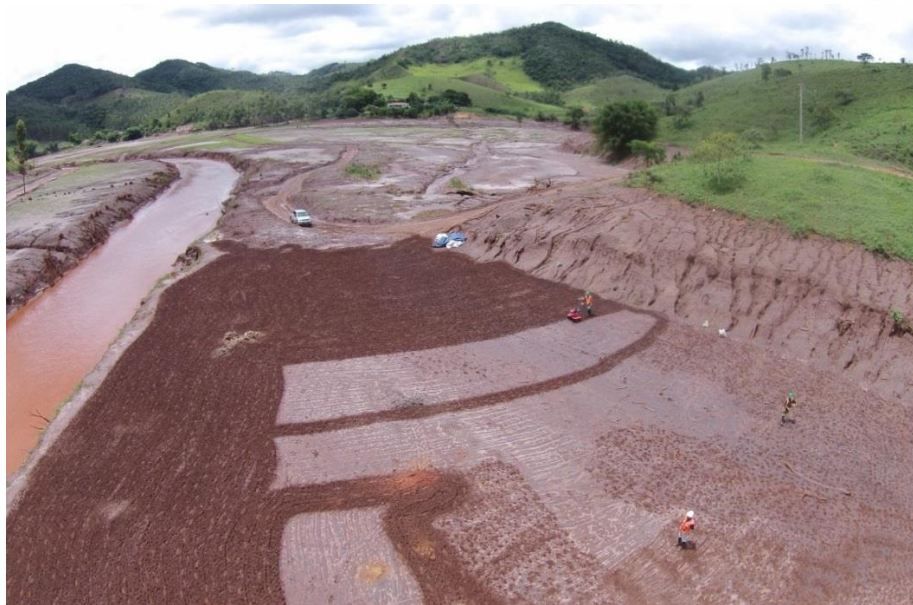
Figure 42: Preparation of the soil utilizing manual and semi-mechanized methods of scarification of the substrate, seeding and fertilization being executed near Paracatu de Baixo

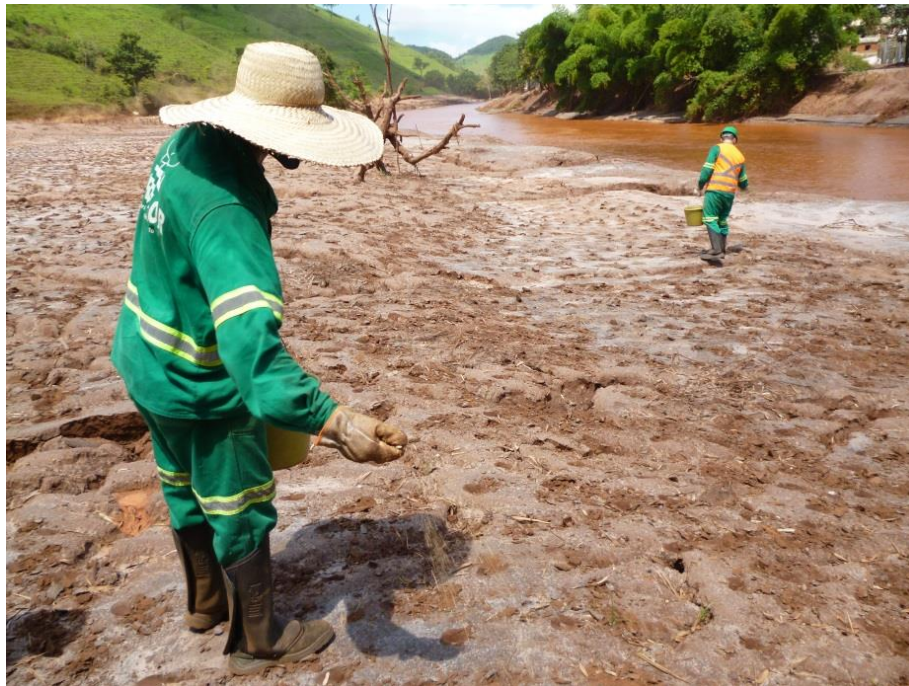
After the scarification of the substrate, the seeds are applied casting (hand sowing). During the experimental phase of the Program of Initial Establishment of the Vegetation Cover an application rate of seeding above the normal was used (400 Kg/ha). This high rate was utilized due to the uncertainties regarding the indices of germination. However, as the germination has been high, the utilization of seeds will be reduced to 300 Kg/ha during the revegetation phase in APPs. This quantity of seeds per hectare is still considered conservative.

Figure 43: Seeding by casting performed by local workers.

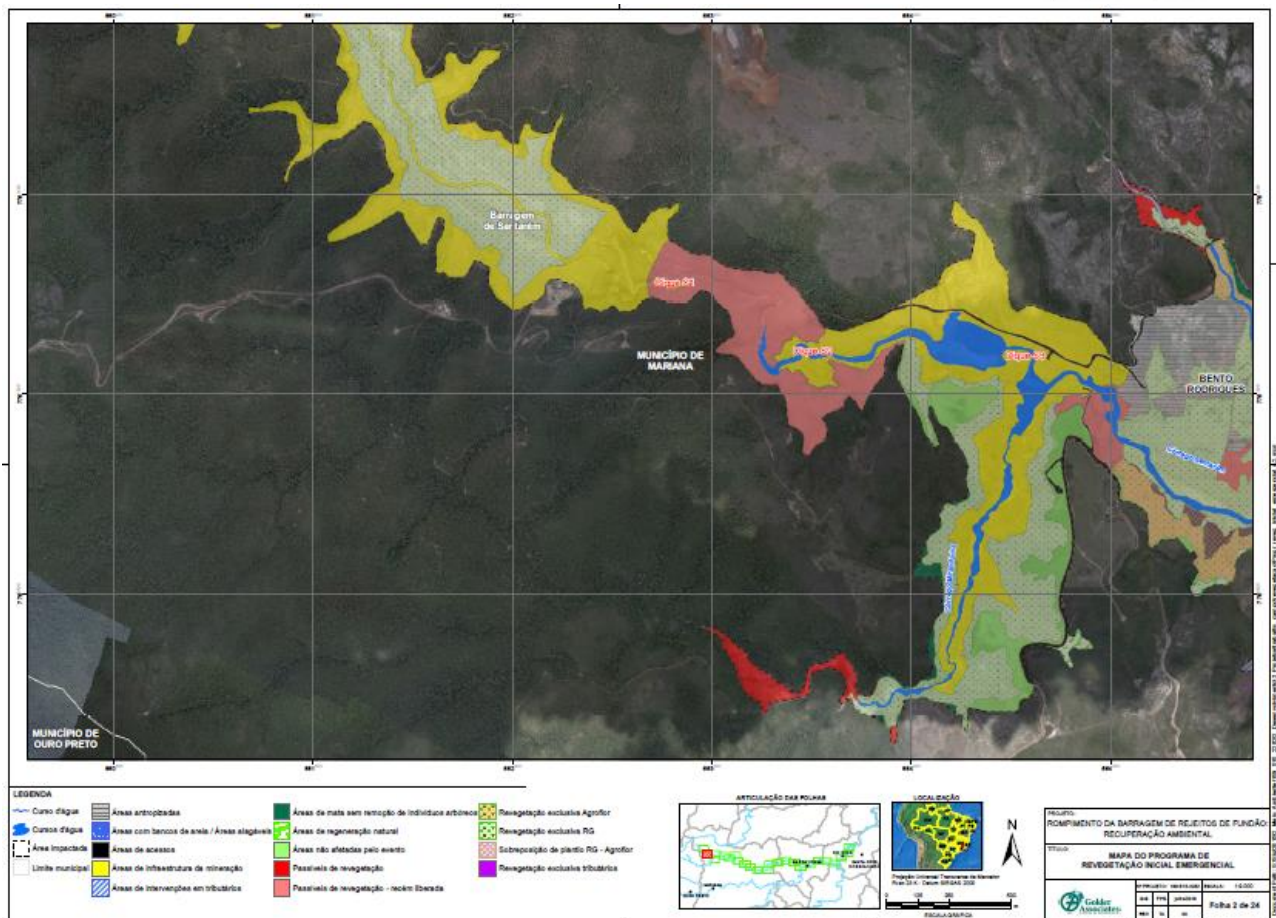
Figure 44: Map of the program of initial emergency revegetation. (Source: Golder Associates).

Immediately below, please refer to examples of maps with the areas re-vegetated (Figures 44 and 45). This information was obtained from topographical data by ERG

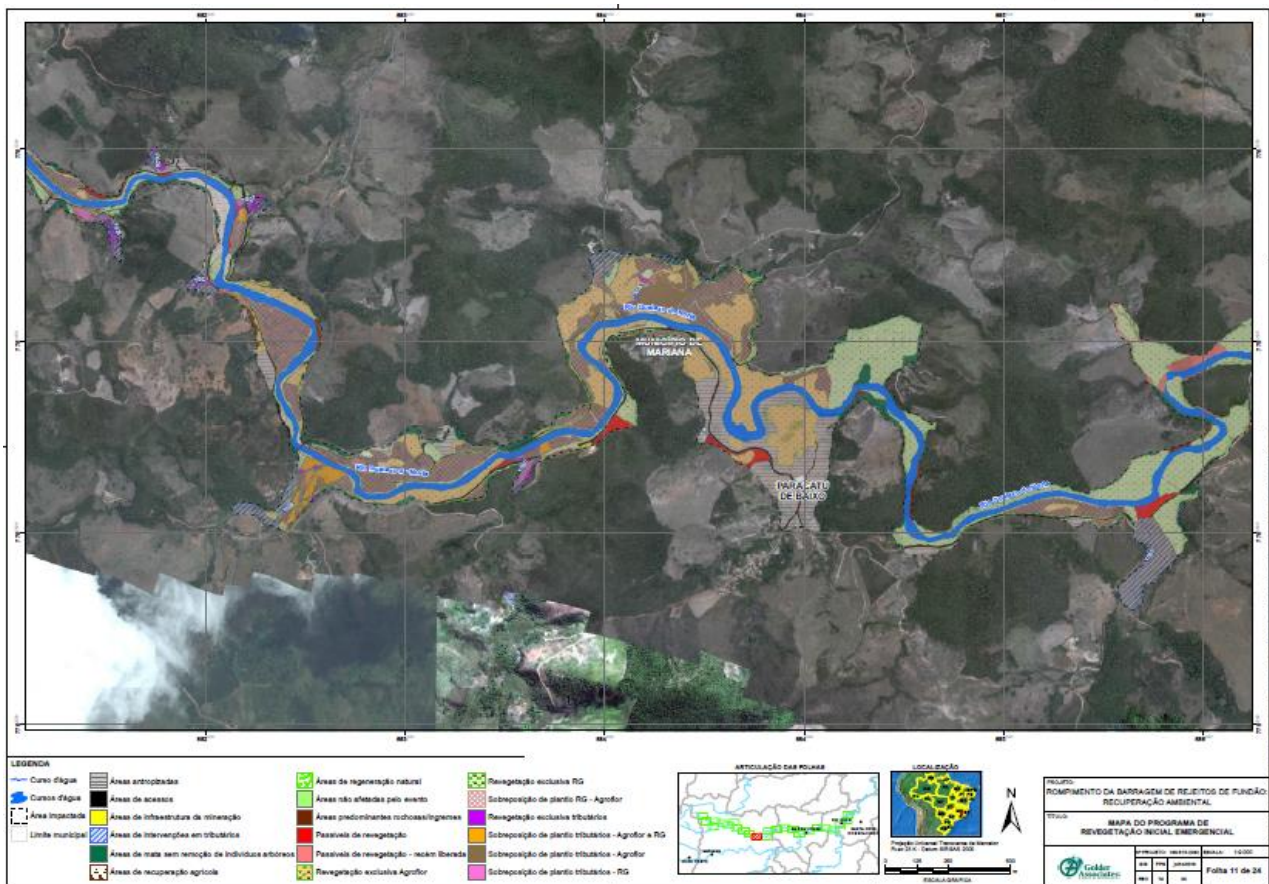
Figure 45: Map of the program of the Initial Emergency revegetation . (source: Golder Associates).

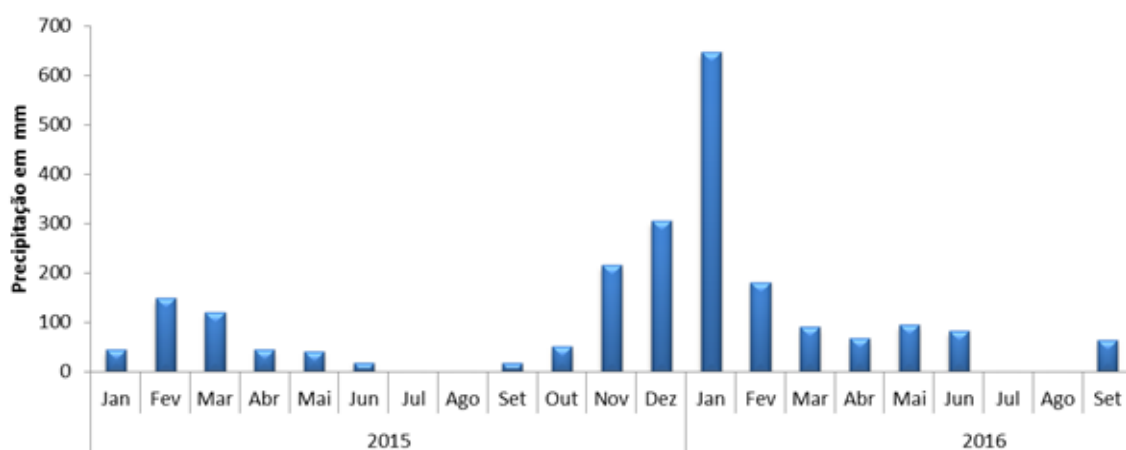
Figure 52: Accumulated monthly rainfall recorded at the Germano Complex in 2015 and 2016

During the rainy period, which goes from October to March, the levels of precipitation present greater intensity, as per the example presented in **Figure 52**.

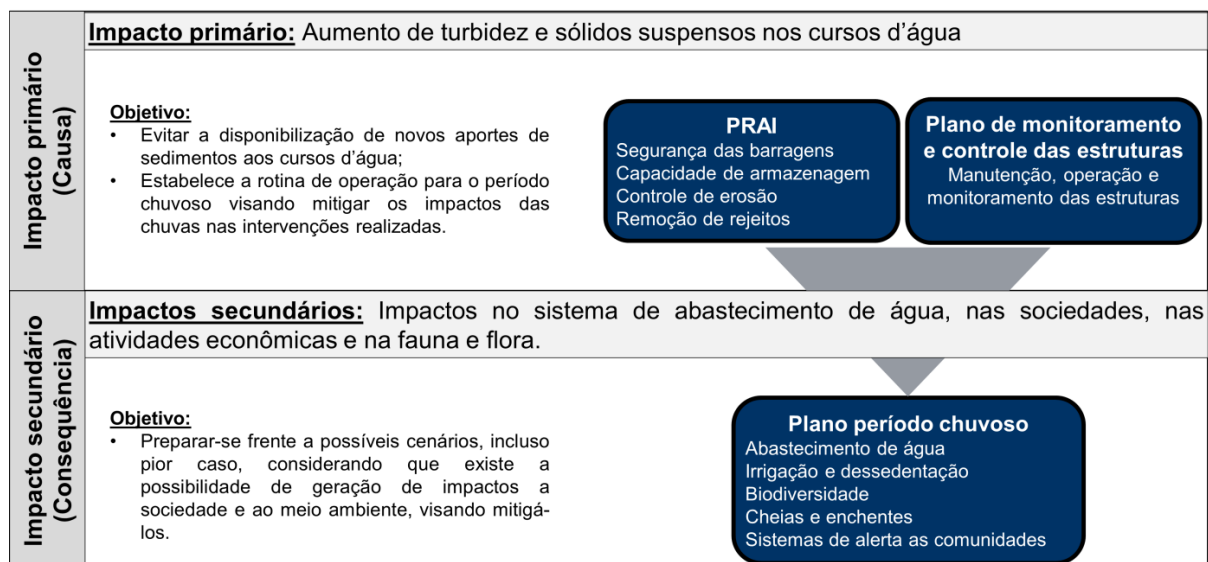
Figure 53: Integrated strategy for preparation of the next rainy period.

Figure 53, which follows, presents schematically the logic strategy developed to meet this demand.

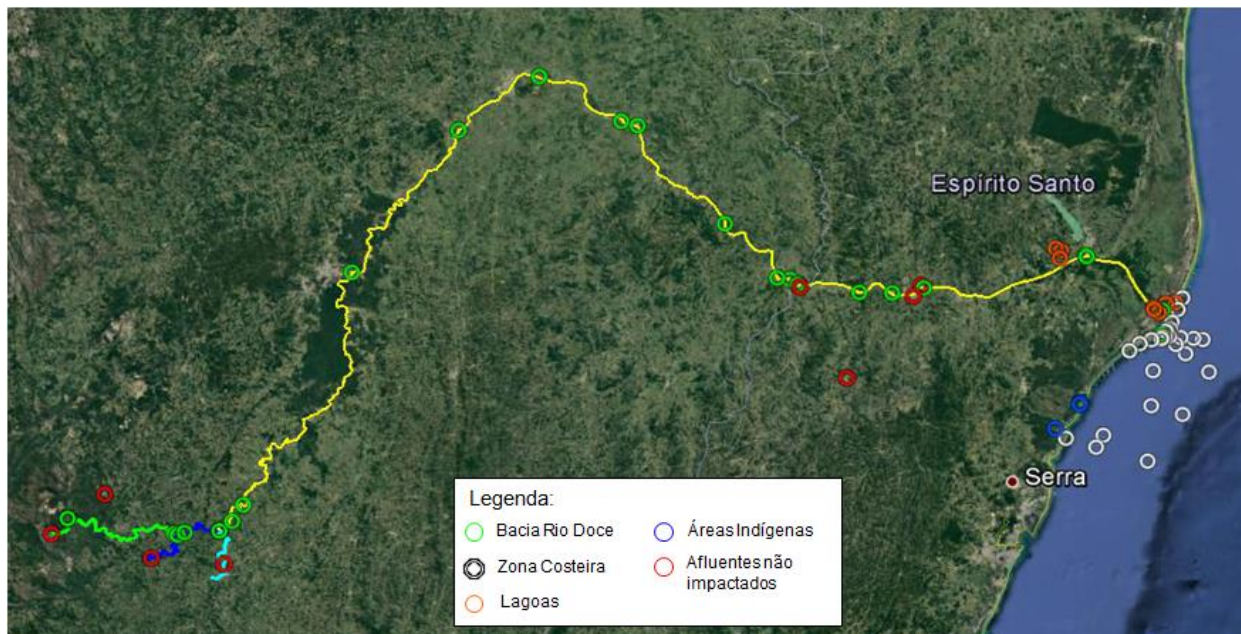
Figure 545 – Sediment Collection and Analysis points.

The monitoring points of water quality and sediments are distributed along the Hydrographic Basin of the River Doce, lagoons of Linhares (ES), indigenous areas and coastal zone in the North of Espírito Santo. In all, there are 114 monitoring points which are represented especially in the Figures 55 and 56:

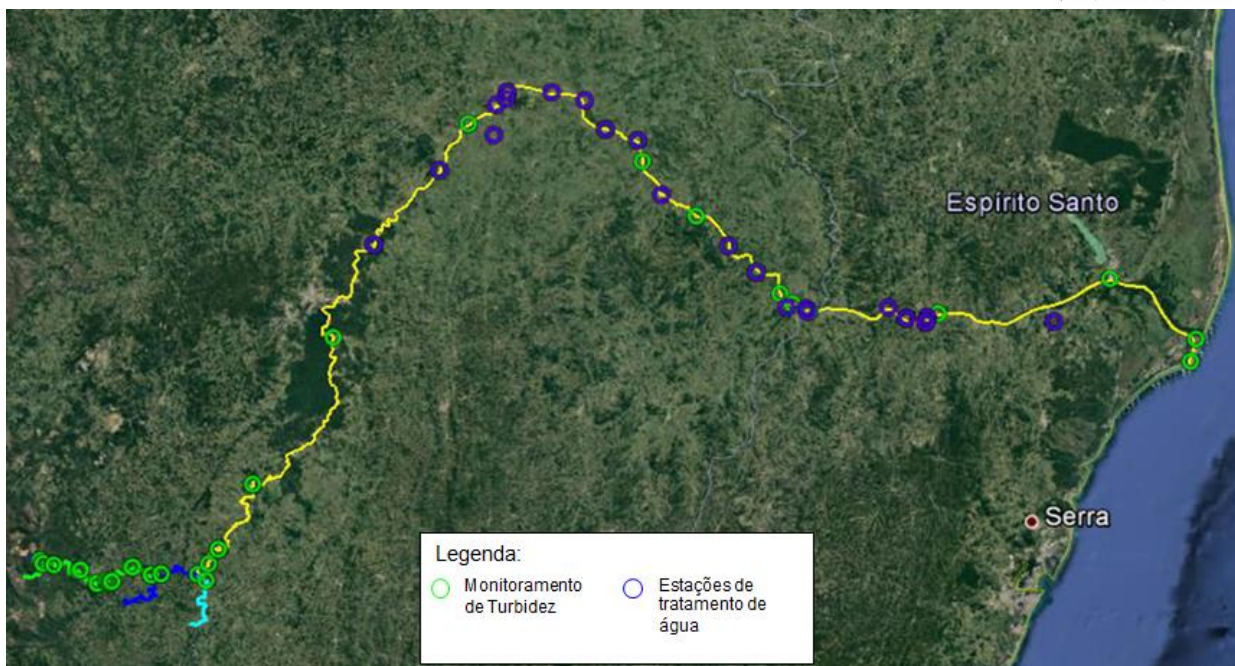
Figure 556 – Turbidity Monitoring Points and ETA's.

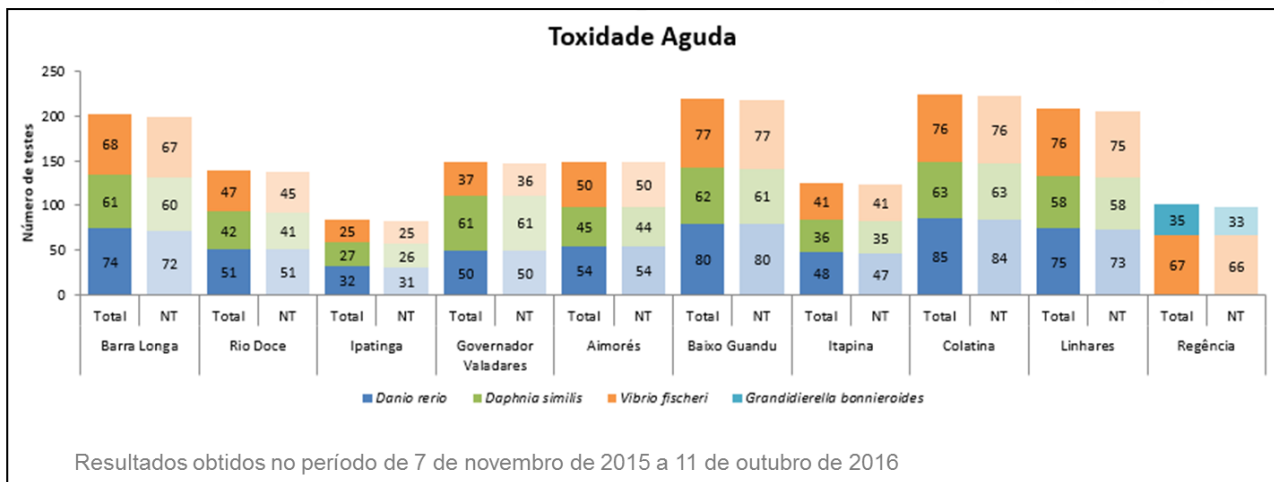
As shown in Figure 56, the toxicity results indicated, almost entirely, the absence of acute toxicity along the entire length of the River Doce.

Figure 567 – Acute Eco-toxicity - Total: number of tests performed. NT: Non-Toxic

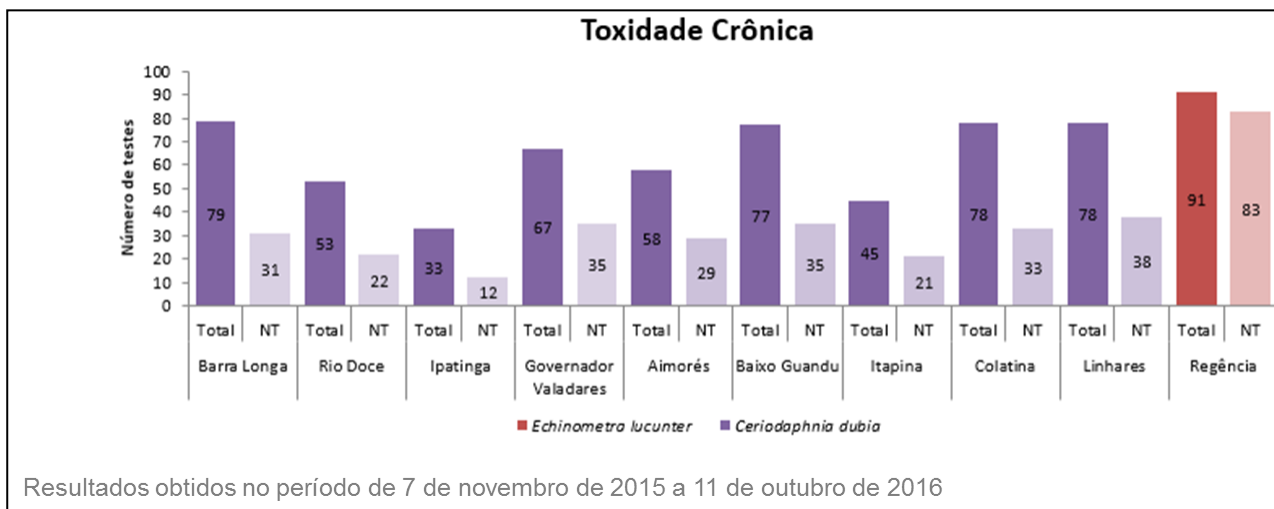
Chronic toxicity tests show that the effects observed during *C. dubia* tests on unfiltered water samples disappeared after the time required for sedimentation of the sample. This pattern suggests a reaction to a physical stress, rather than a response to a chemical effect.

Figure 57 – Chronic Eco-toxicity - Total: number of tests performed. NT: Non-Toxic

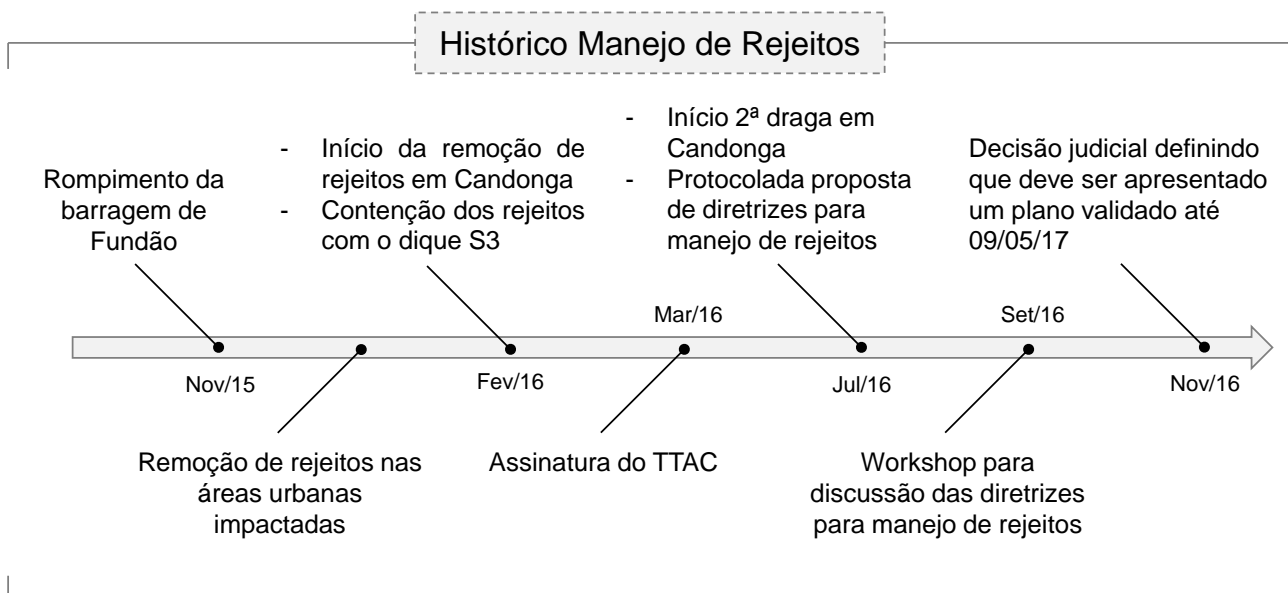
Figure 59 – History of the Activities related to Tailings Management.

The historical sequence of the principal milestones related to the tailings management is presented in a summarized form in **Figure 59**.

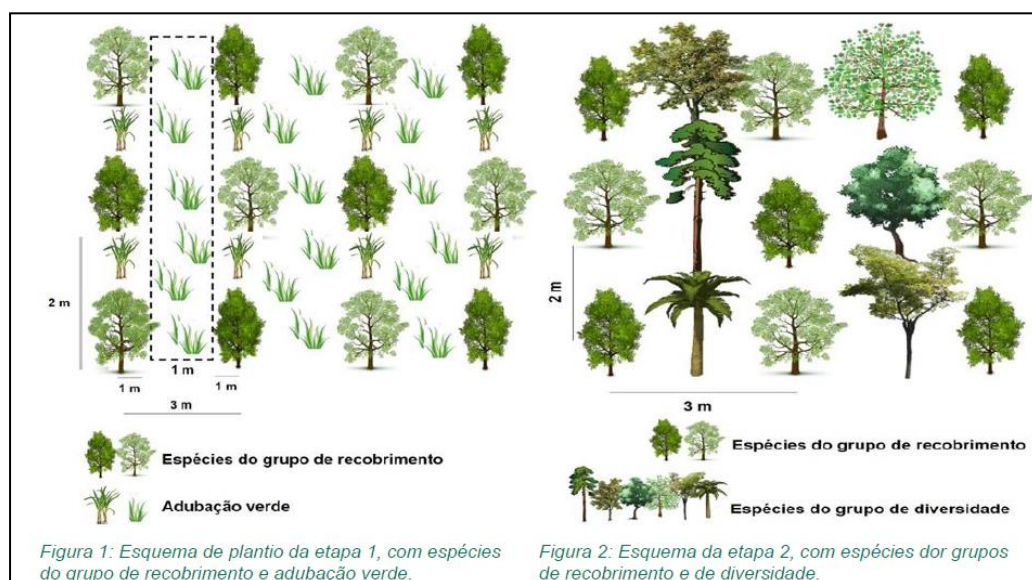
Figure 58 – Rehabilitation models tests 1 and 2

The tests will be carried out in areas representative of the soil conditions most common in the area to be restored, using re-vegetation practices with seedlings and by direct seeding. Periodically, the soils and substrates of interest Will be sampled for physical, chemical and biological analyses.

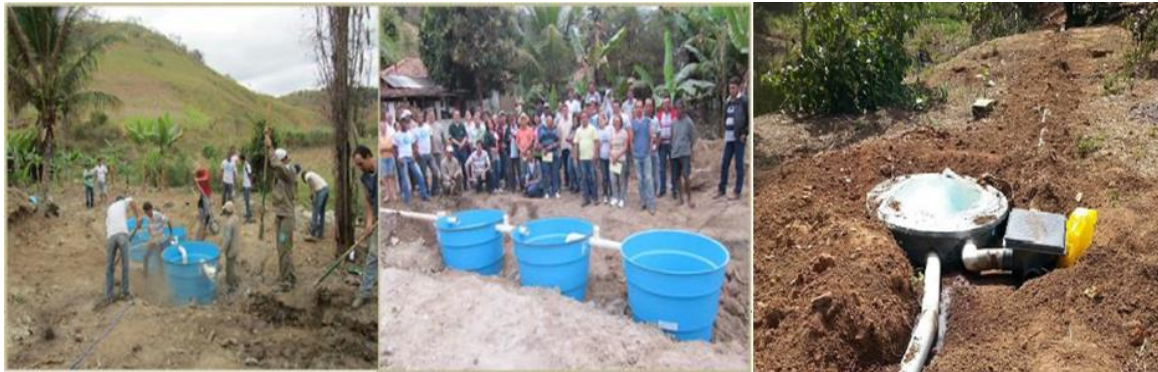
Figure 59: Installation of septic tanks (archive Instituto Terra).

Figures 62 and 63 show examples of the actions of installation of septic tanks and construction of small dams on the rural properties.

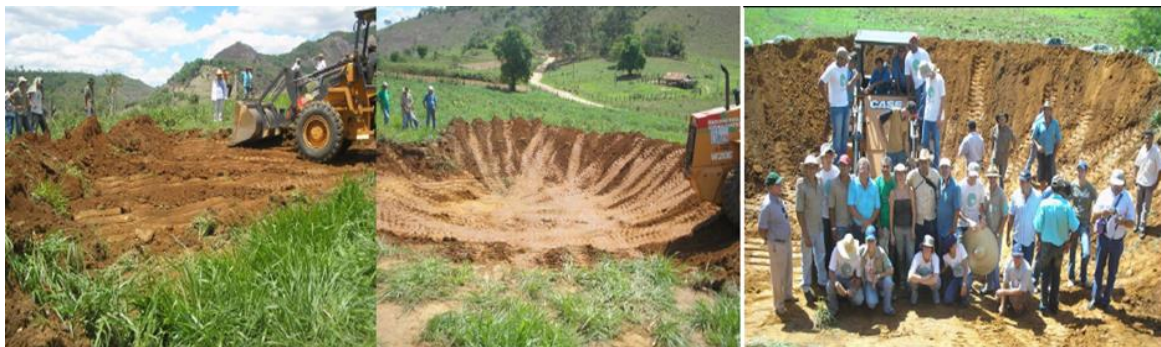
Figure 62: Construction of catchment basins (archive Instituto Terra).

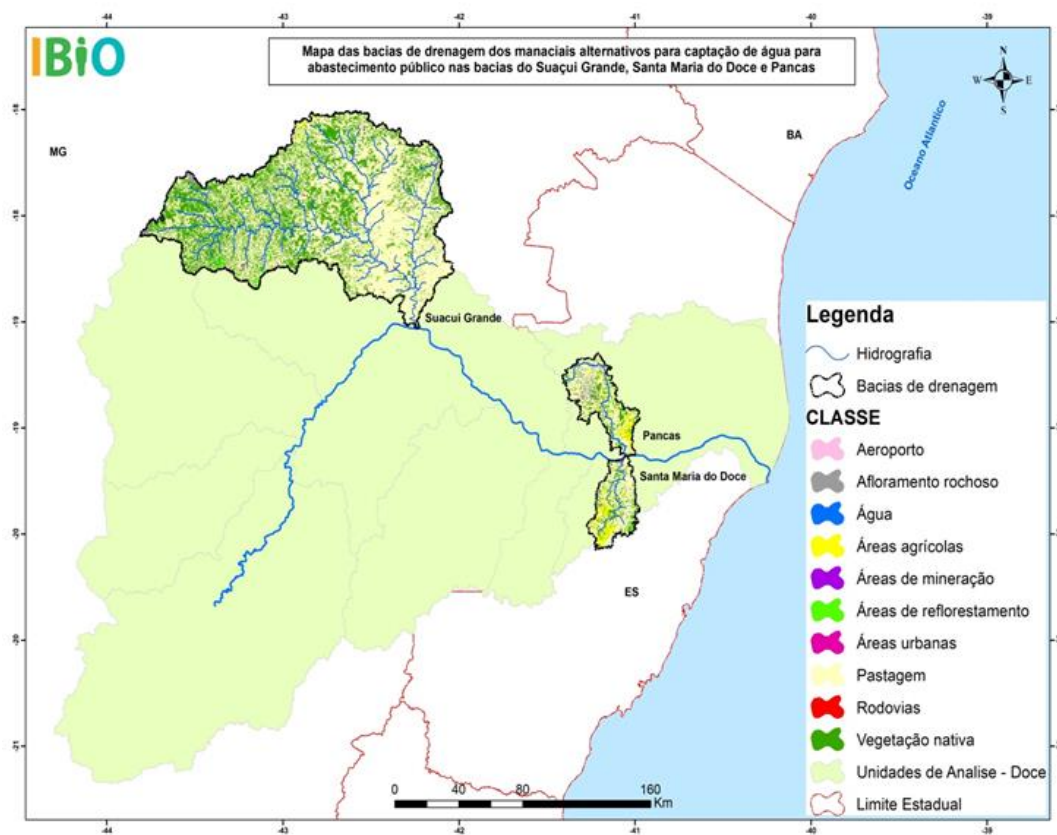
Figure 603: Sub-basins prioritized for reclamation of first 500 springs.

For the first year of spring reclamation, the Doce River Basin Committee – CBH-Doce River Hydrographic Basin Committee Doce, defined three priority sub-basins, namely, Pancas and Santa Maria do Doce in Colatina and Suaçui Grande in Governador Valadares. Figure 63 shows schematically the sub-basins which were prioritized in the recovery of the first 500 springs.

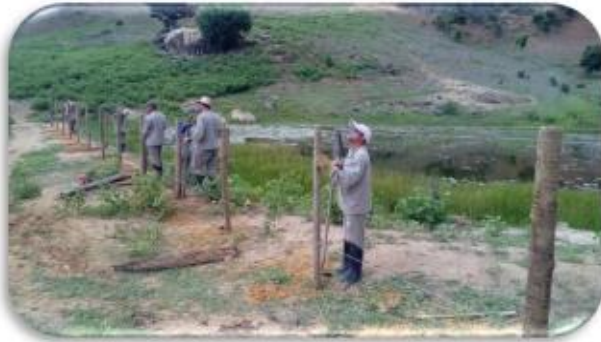
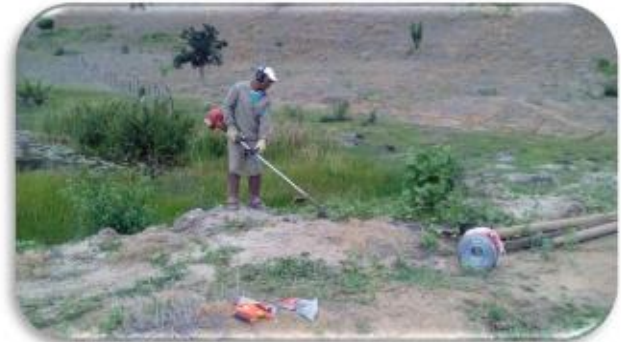
Figure 65 - Instituto Terra team building fences and performing selective land clearing.
