**Updated Integrated Environmental
Recovery Plan
PRAI**

January 2017

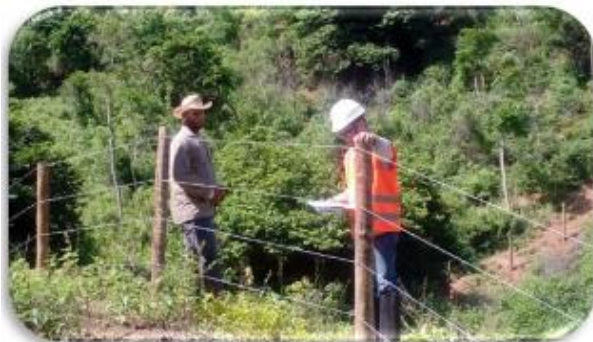
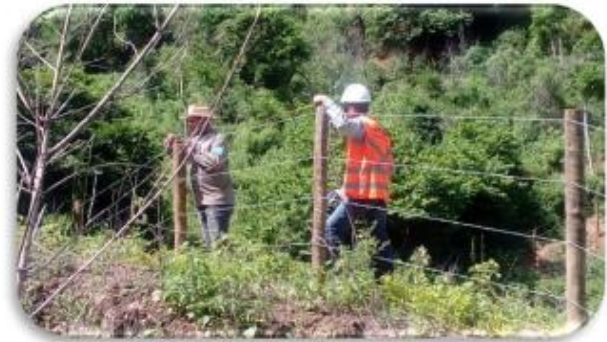
Figure 66 – Fencing inspection.
